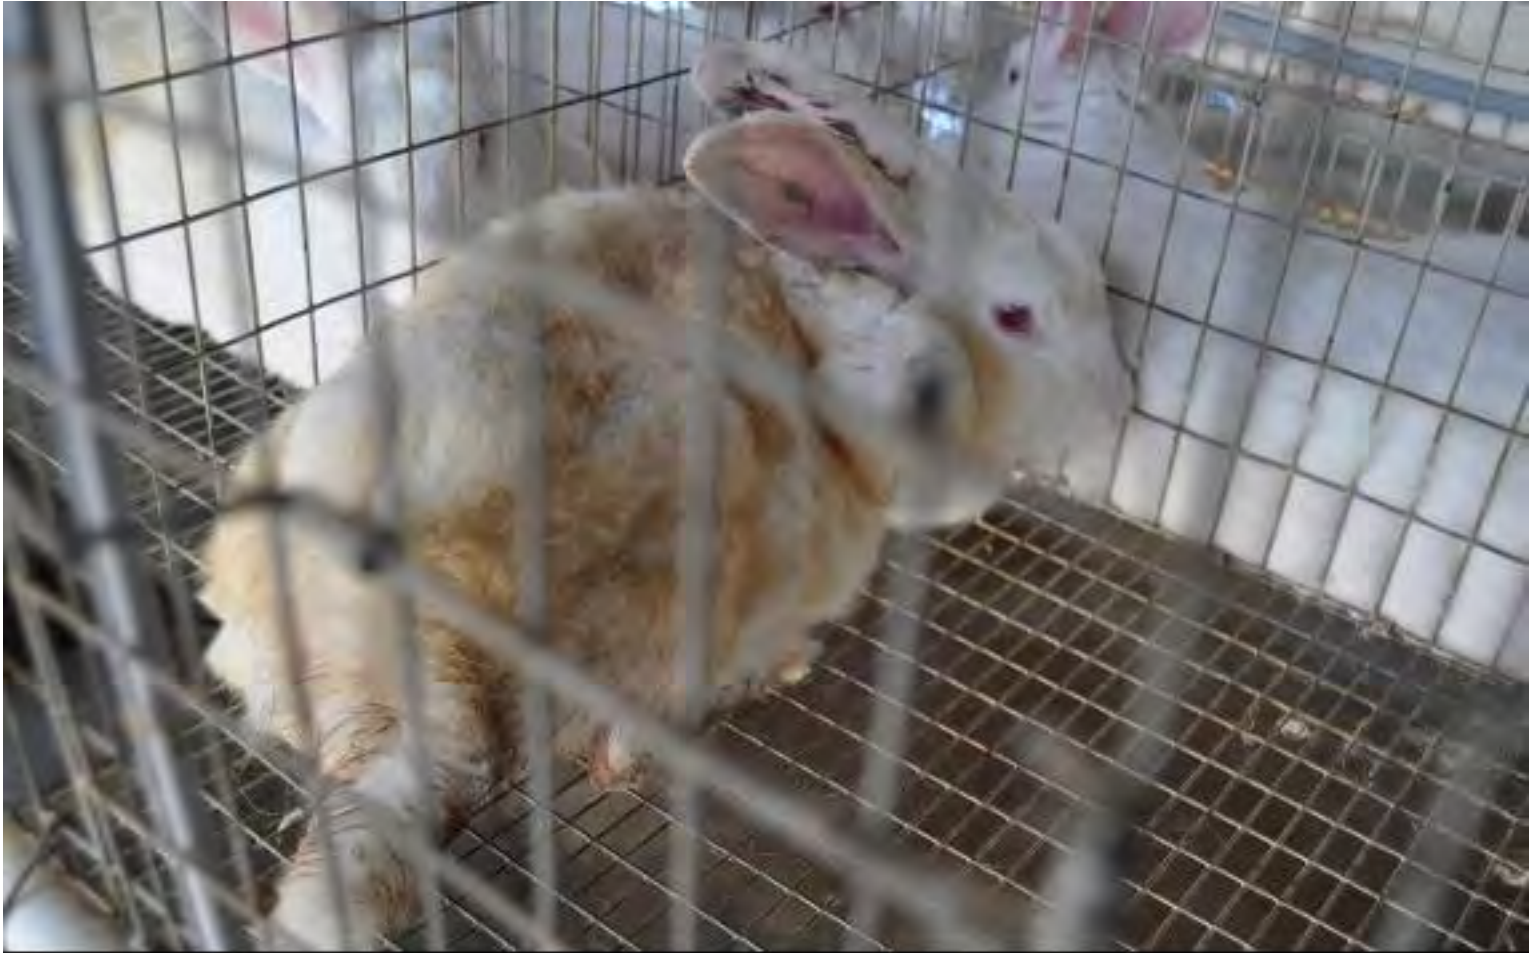
CFR: 2.33 (b) (2)

Photographer:	Jeff Lee	Legal Name:	93-R-0521
Photo Taken:	Wed, Jul 29, '15	PRO SCI INC.	
Inspection:	211151857550456		
Description:	Rabbit is underweight, depressed, and soiled. Veterinary care is needed.

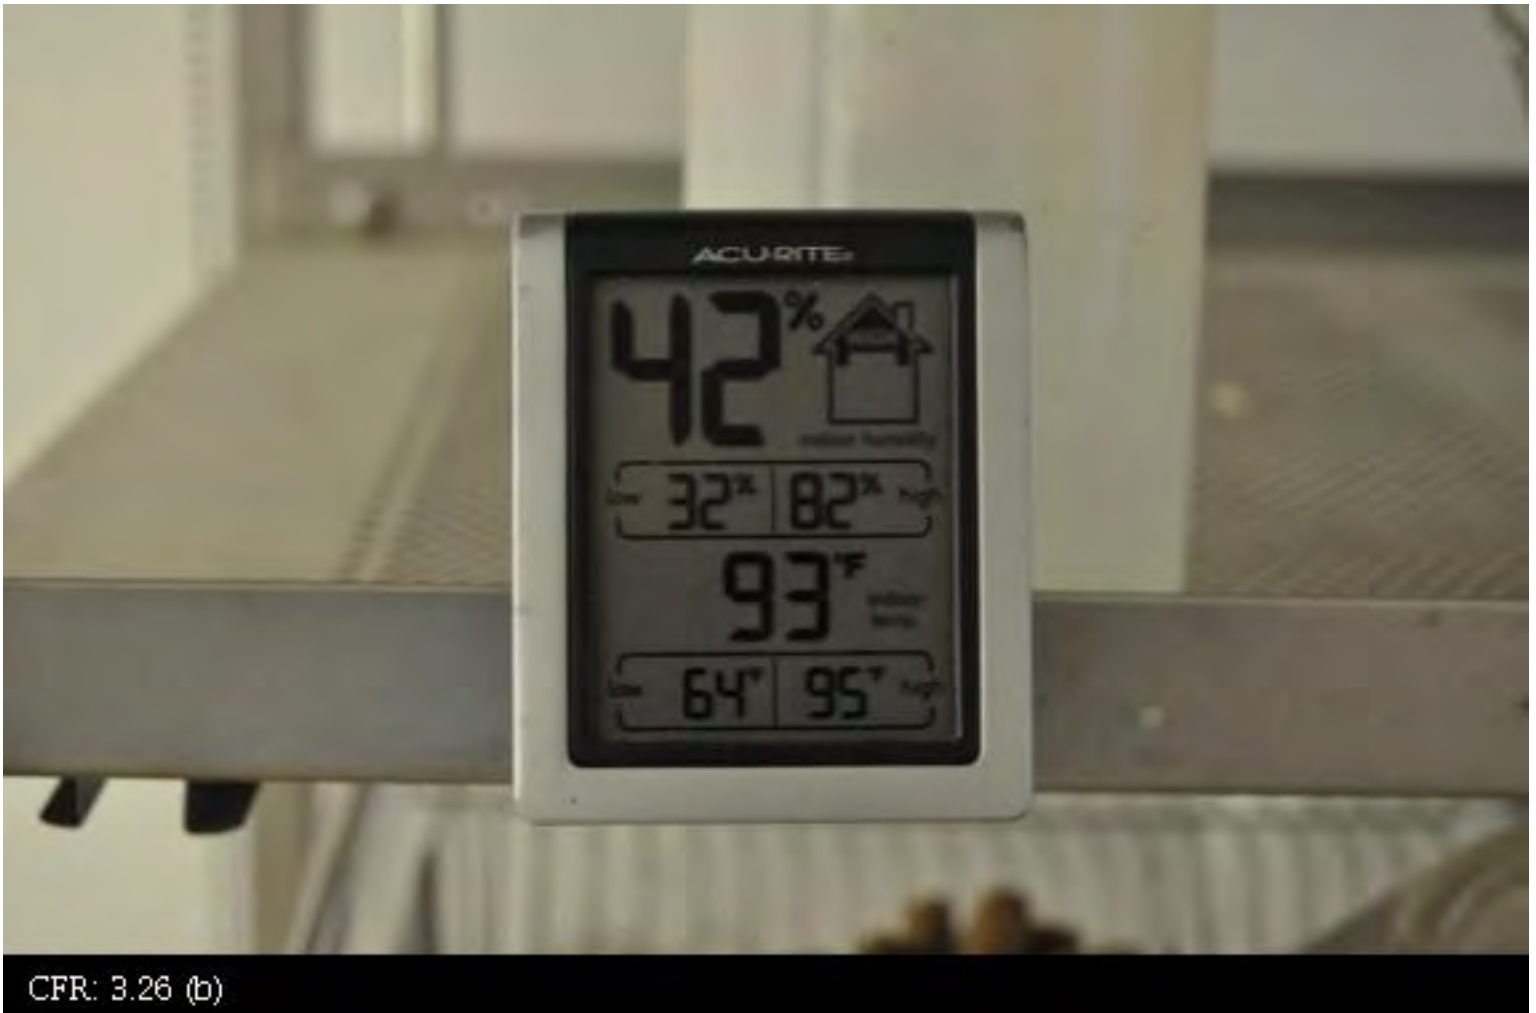
CFR: 3.26 (b)

Photographer:	Jeff Lee	Legal Name:	93-R-0521
Photo Taken:	Wed, Jul 29, '15	PRO SCI INC.	
Inspection:	211151857550456		
Description:	the guinea pig/ hamster room is 93 degrees F. Air conditioner is not functioning. The room is not adequately ventilated.

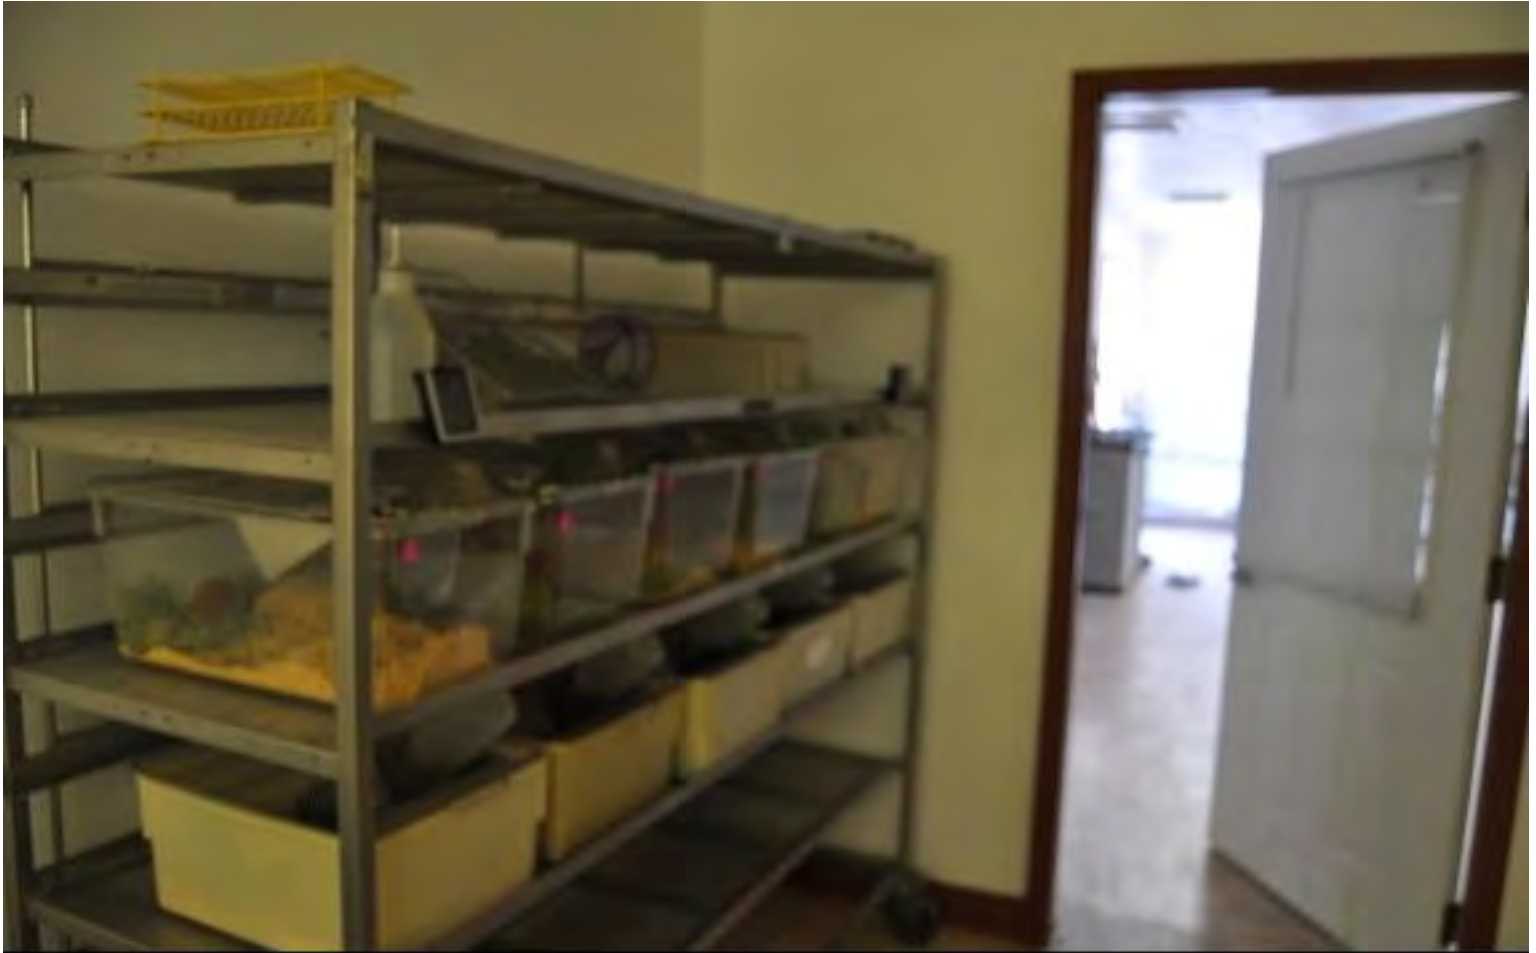
CFR: 3.26 (b)

Photographer:	Jeff Lee	Legal Name:	93-R-0521
Photo Taken:	Wed, Jul 29, '15	PRO SCI INC.	
Inspection:	211151857550456		
Description:	the guinea pig/ hamster room is 93 degrees F. Air conditioner is not functioning. The room is not adequately ventilated.

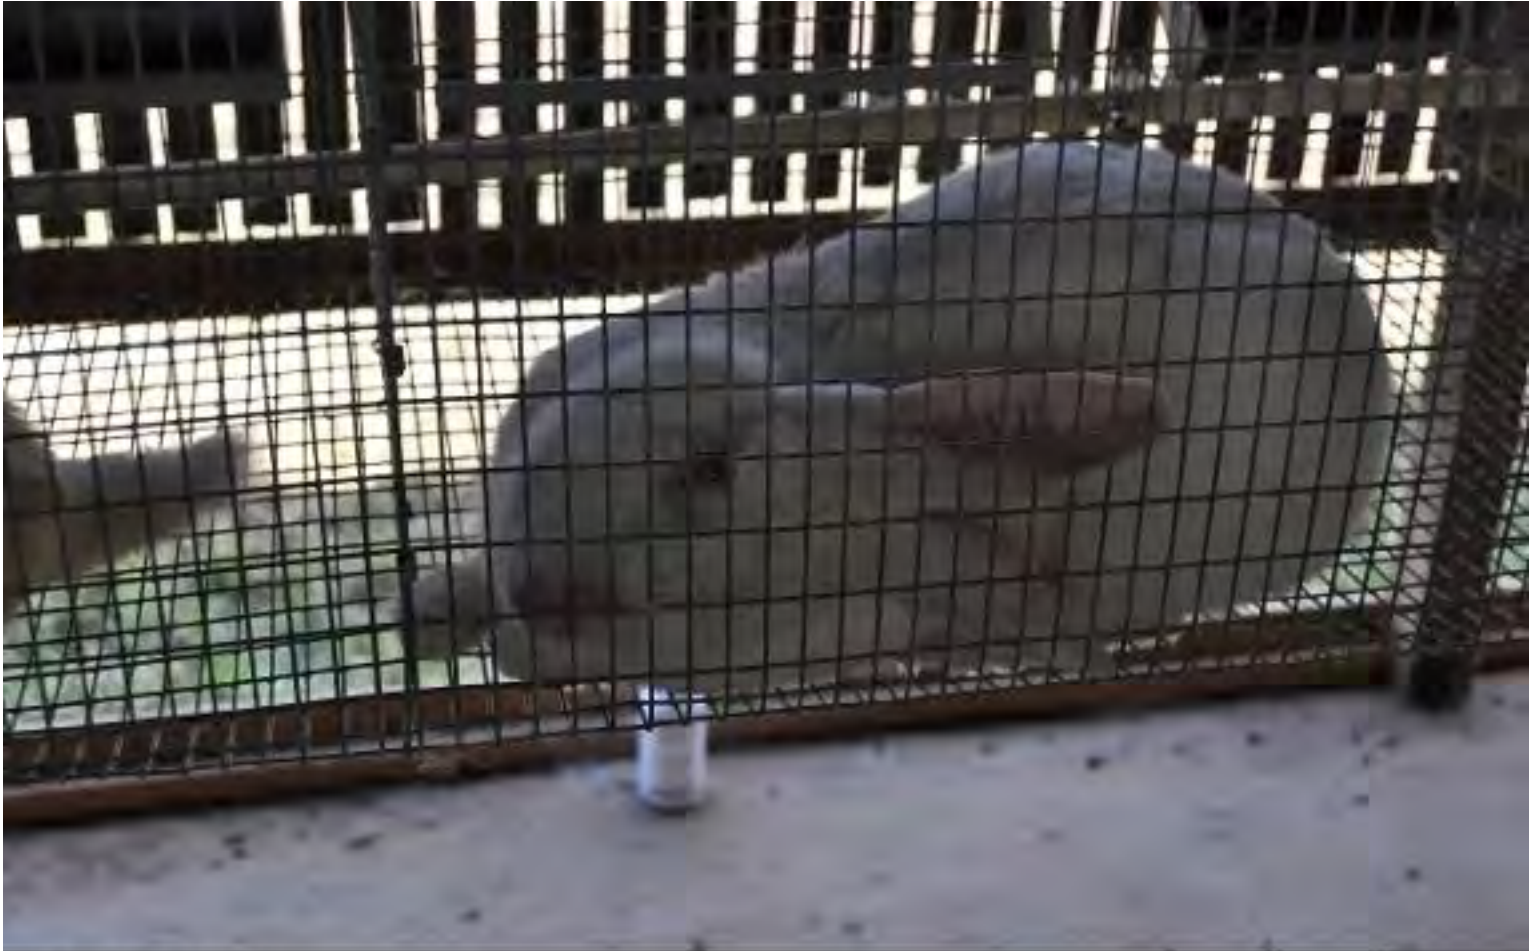
CFR: 2.33 (b) (2)

Photographer:	Jeff Lee	Legal Name:	93-R-0521
Photo Taken:	Wed, Jul 29, '15	PRO SCI INC.	
Inspection:	211151857550456		
Description:	Rabbit with head tilt. Veterinary care is needed.

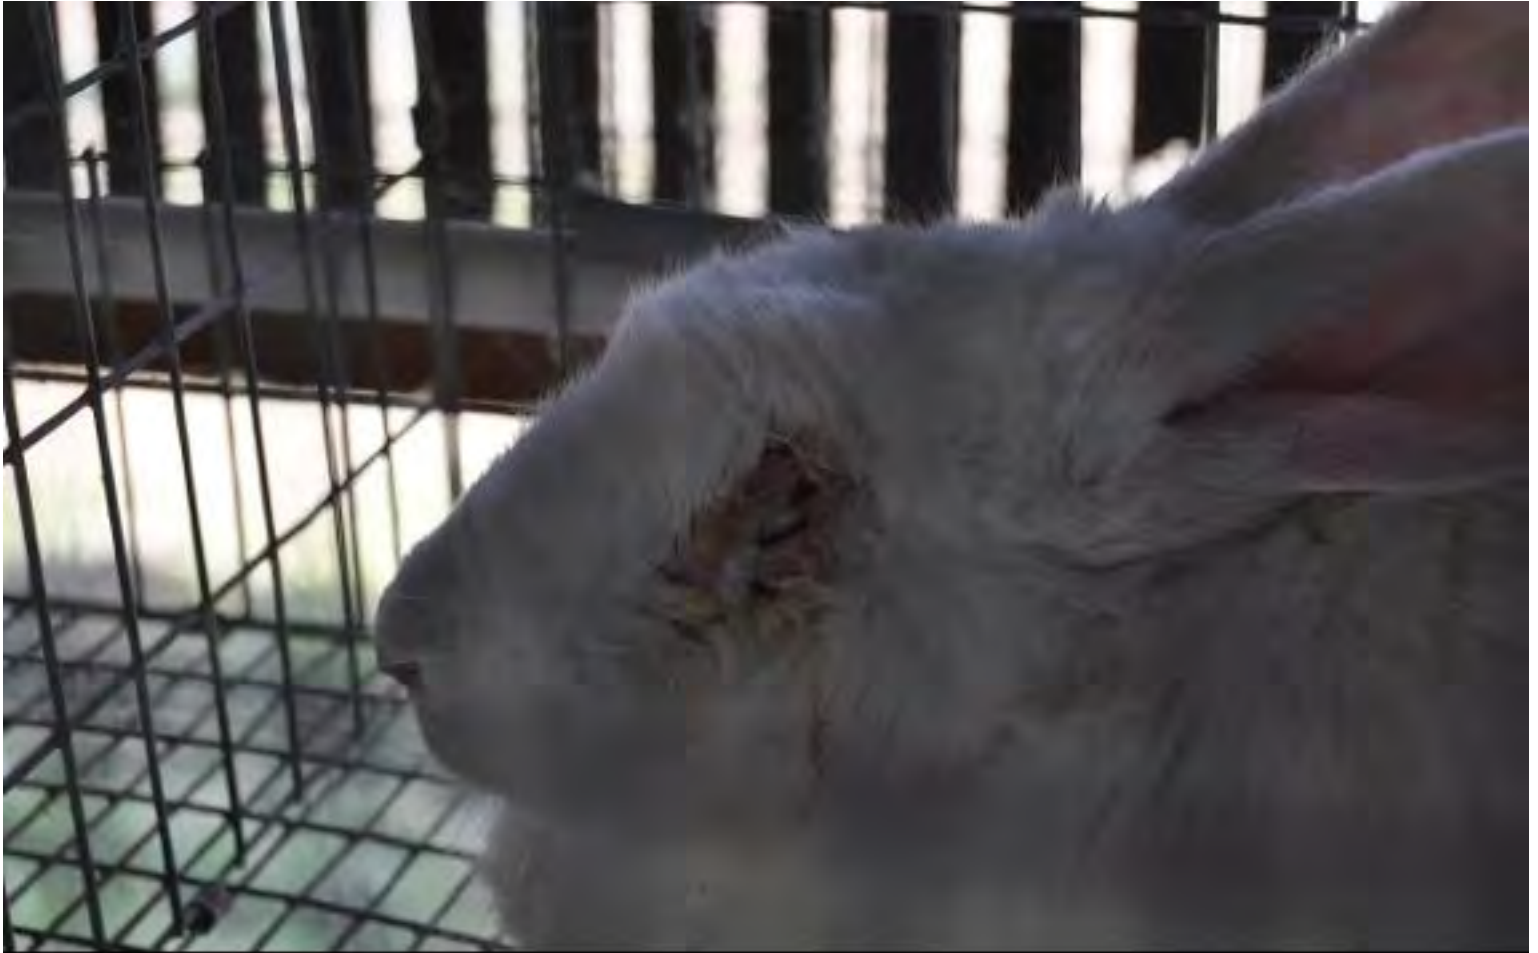
CFR: 2.33 (b) (2)

Photographer:	Jeff Lee	Legal Name:	93-R-0521
Photo Taken:	Wed, Jul 29, '15	PRO SCI INC.	
Inspection:	211151857550456		
Description:	Rabbit with thick yellow discharge in left eye. Veterinary care is needed.

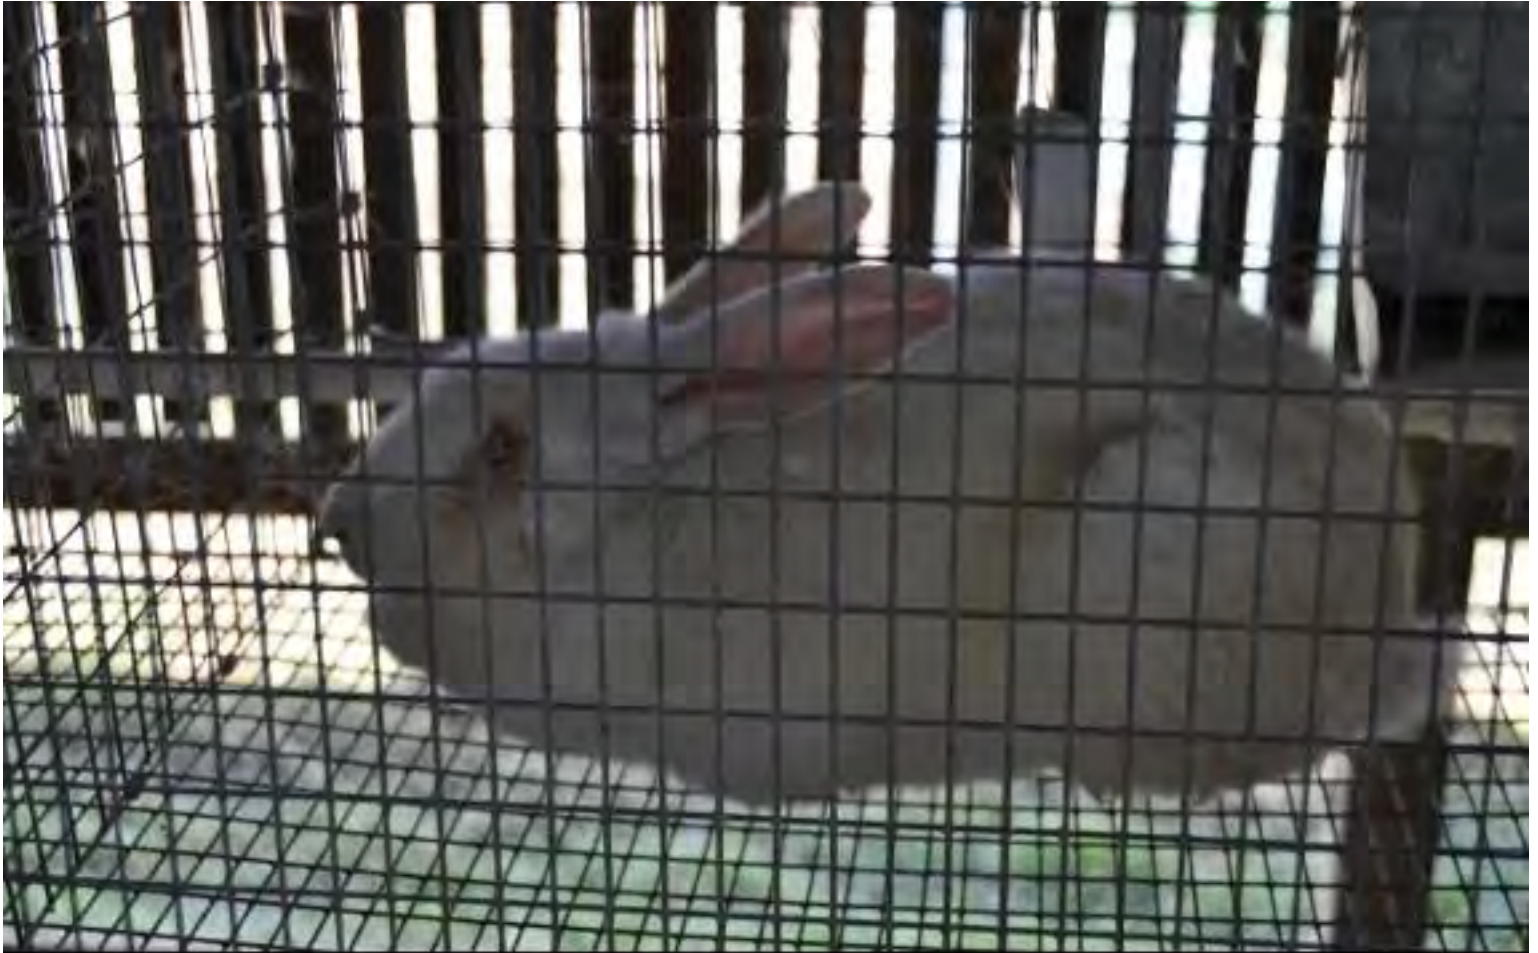
CFR: 2.33 (b) (2)

Photographer:	Jeff Lee	Legal Name:	93-R-0521
Photo Taken:	Wed, Jul 29, '15	PRO SCI INC.	
Inspection:	211151857550456		
Description:	Rabbit with thick yellow discharge in left eye. Veterinary care is needed.

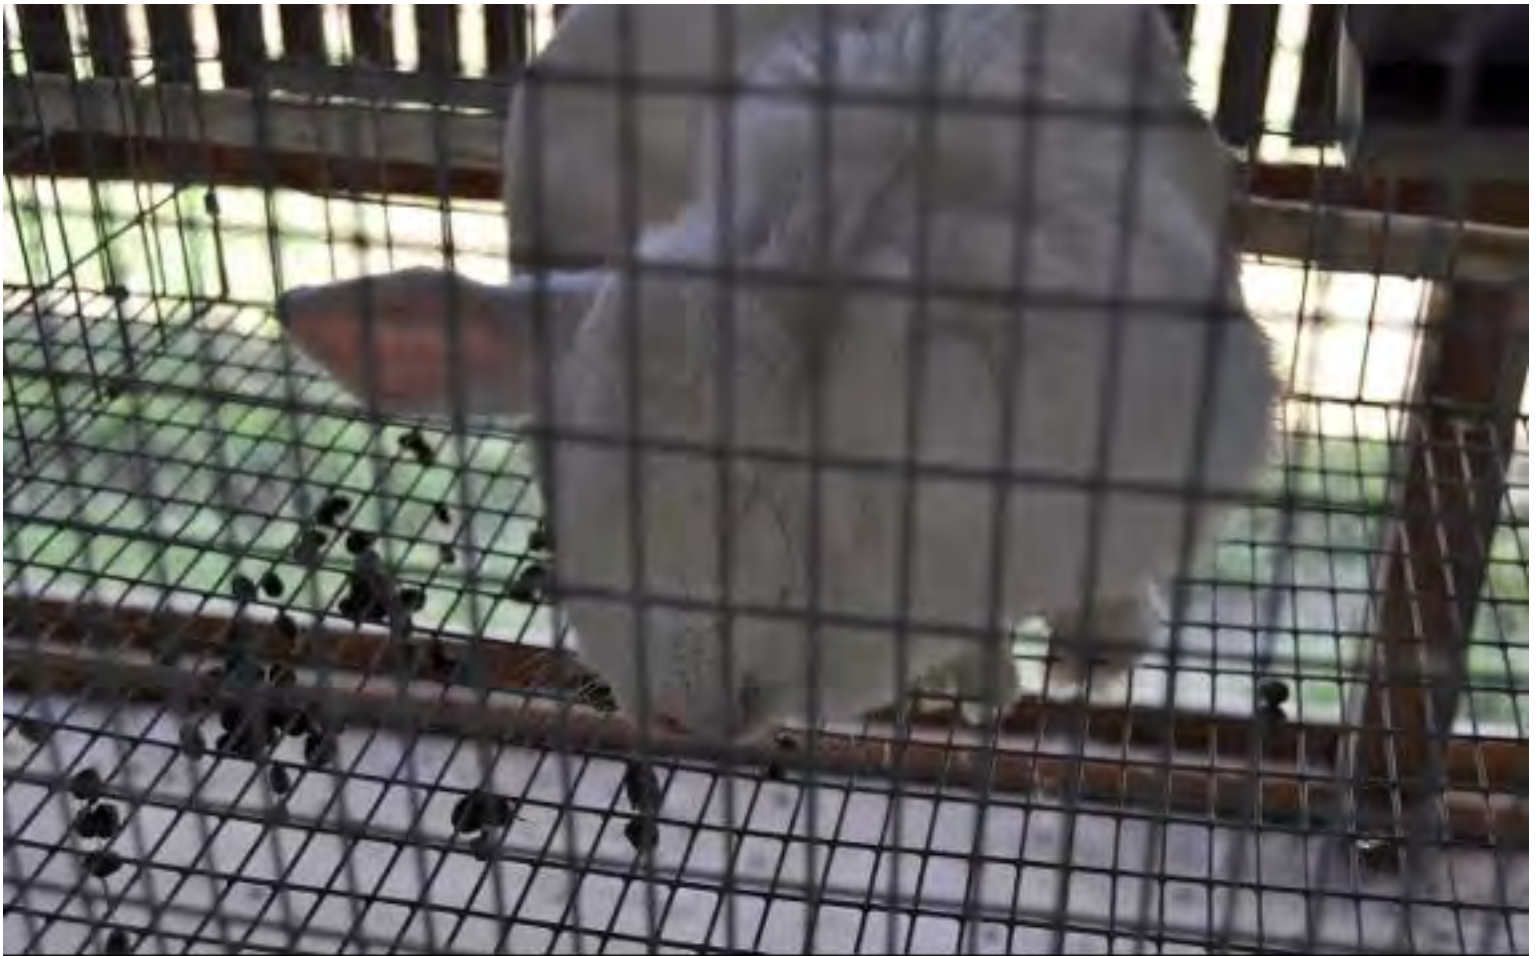
CFR: 2.33 (b) (2)

Photographer:	Jeff Lee	Legal Name:	93-R-0521
Photo Taken:	Wed, Jul 29, '15	PRO SCI INC.	
Inspection:	211151857550456		
Description:	Rabbit with a head tilt. Veterinary care is needed.

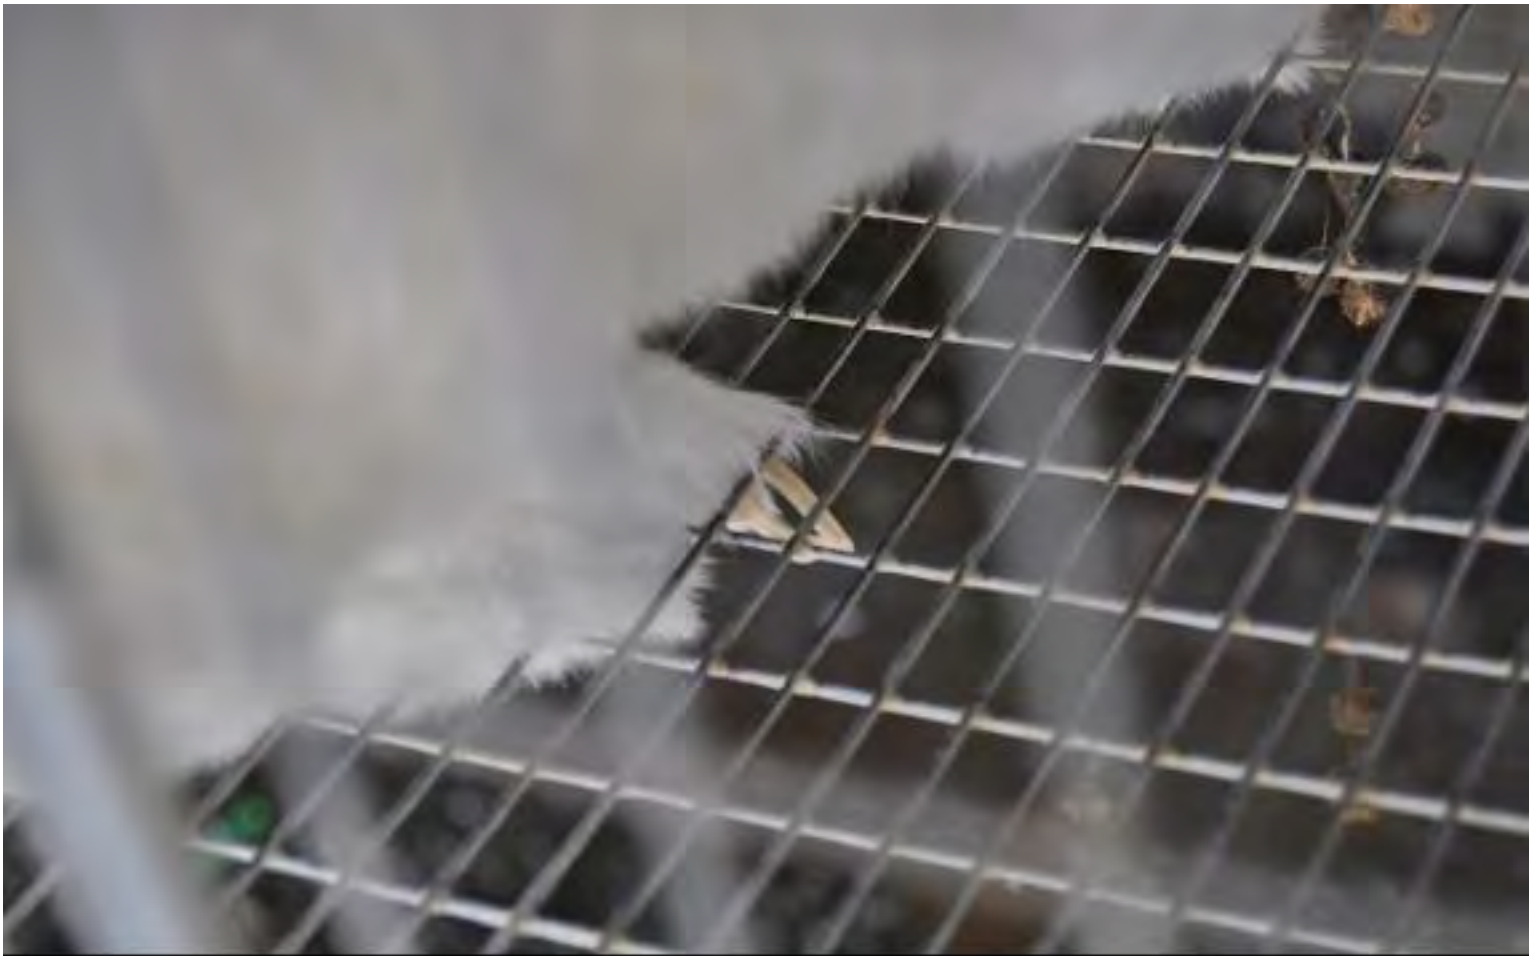
CFR: 2.33 (b) (2)

Photographer:	Jeff lee	Legal Name:	93-R-0521
Photo Taken:	Wed, Jul 29, '15	PRO SCI INC.	
Inspection:	211151857550456		
Description:	Rabbit with overgrown nails.

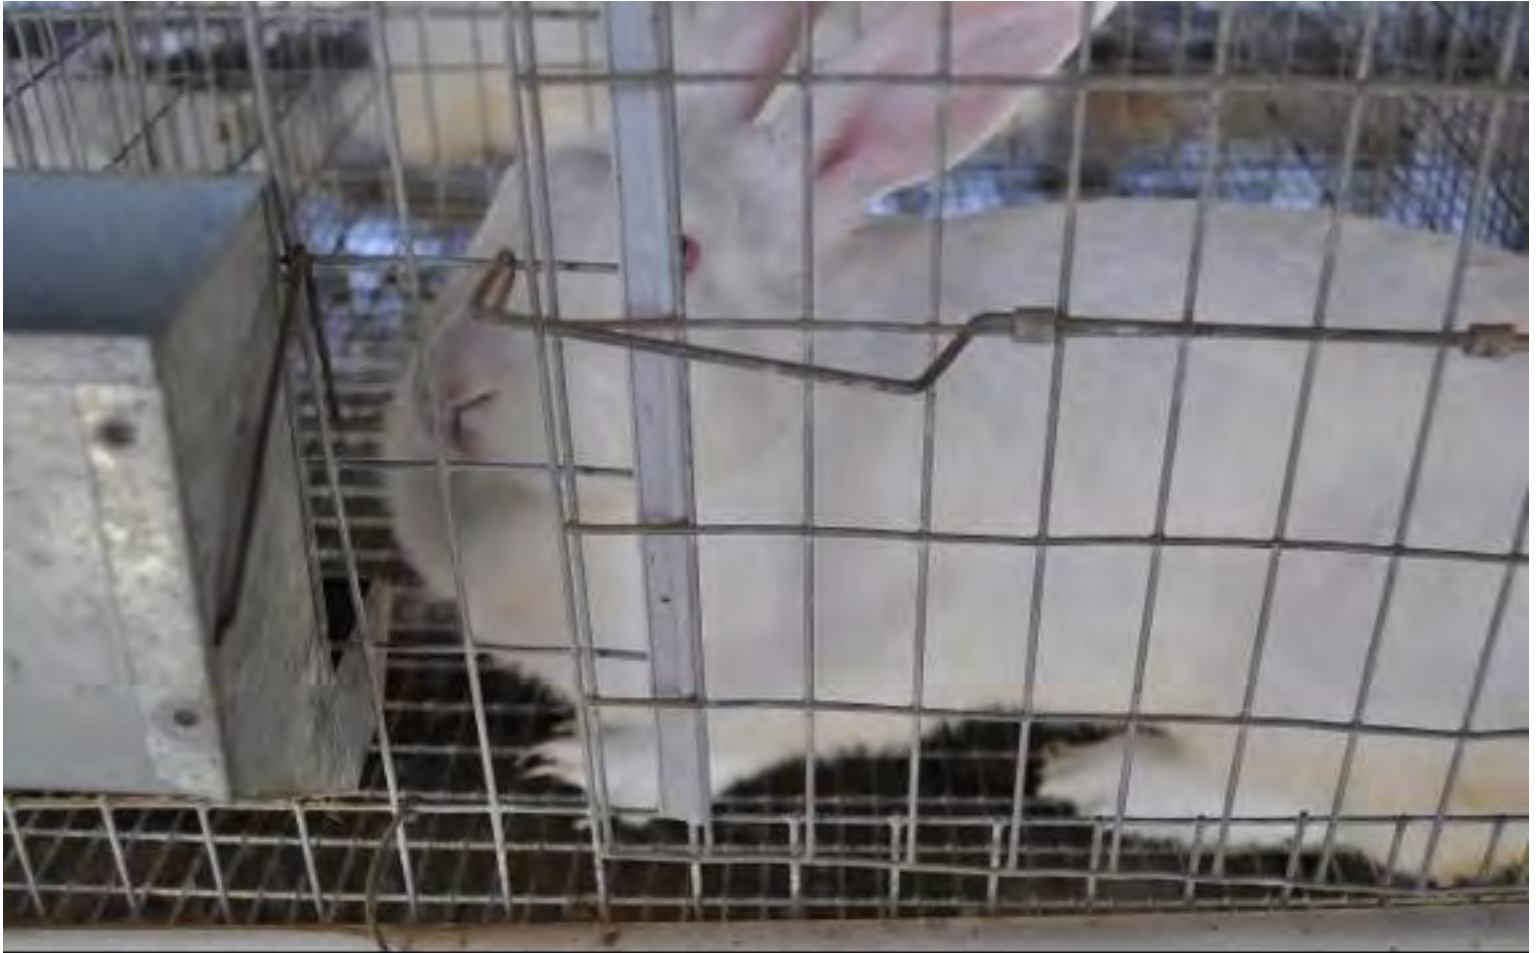
CFR: 2.33 (b) (2)

Photographer:	Jeff Lee	Legal Name:	93-R-0521
Photo Taken:	Wed, Jul 29, '15	PRO SCI INC.	
Inspection:	211151857550456		
Description:	Rabbit with overgrown nails

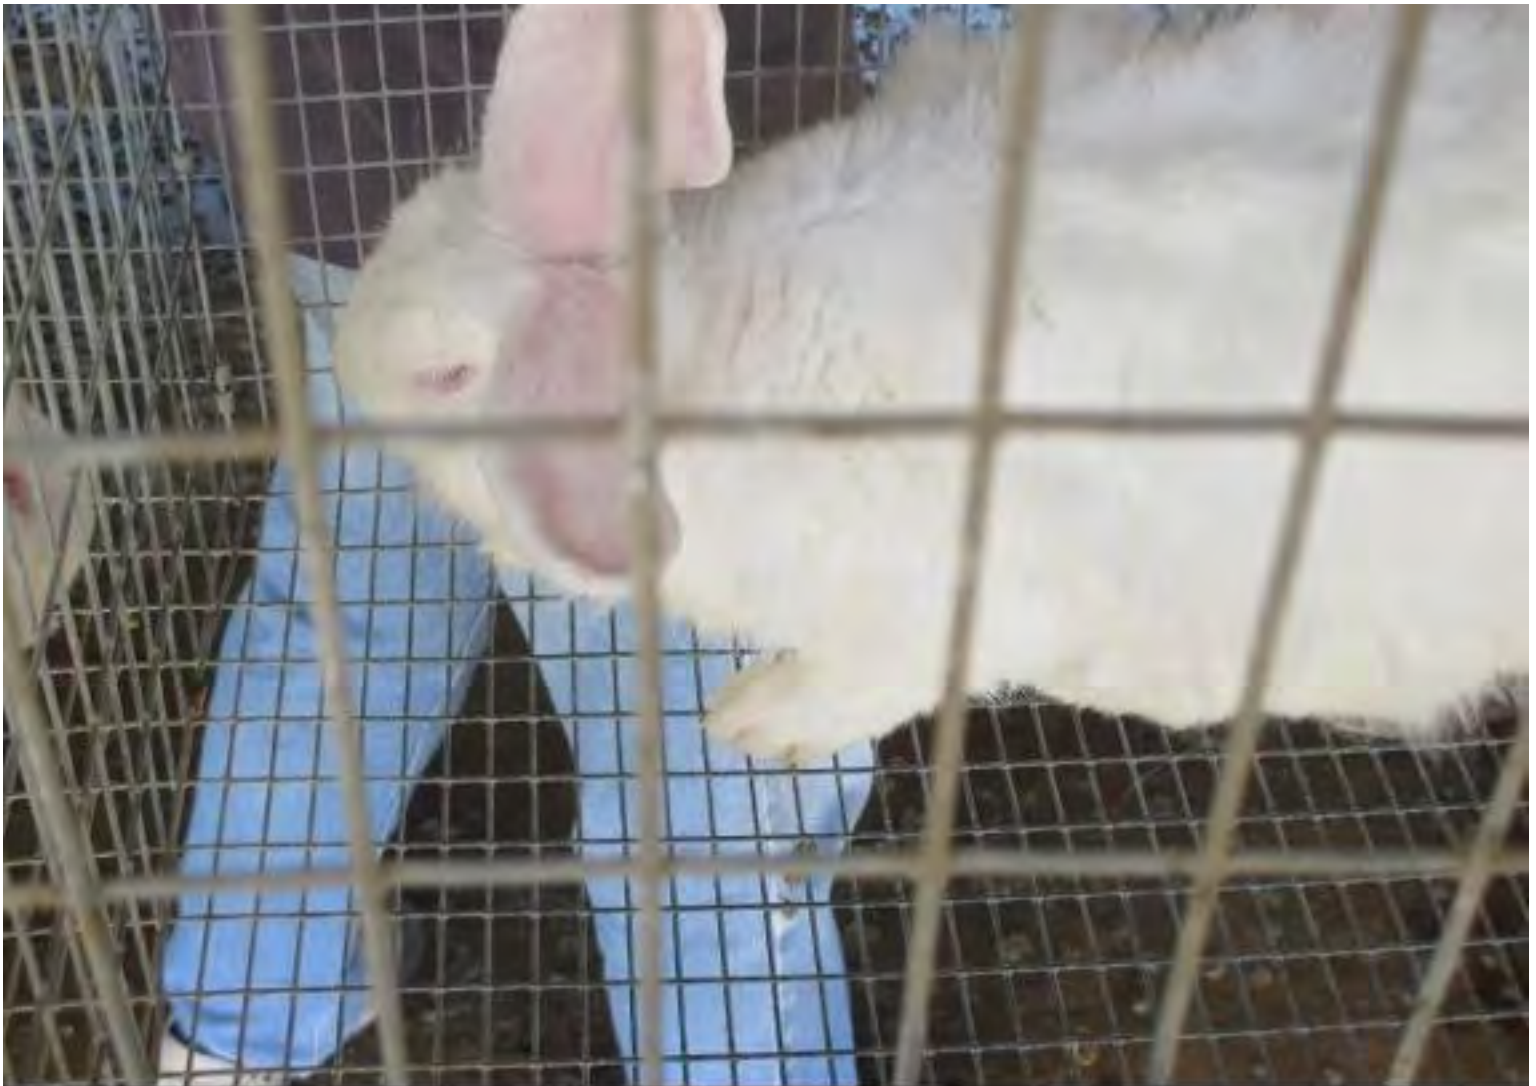
CFR: 2.33 (b) (2)

Photographer:	Tyler Fields	Legal Name:	93-R-0521
Photo Taken:	Wed, Jul 29, '15	PRO SCI INC.	
Inspection:	211151857550456		
Description:	Rabbit with a head tilt. Veterinary care is needed

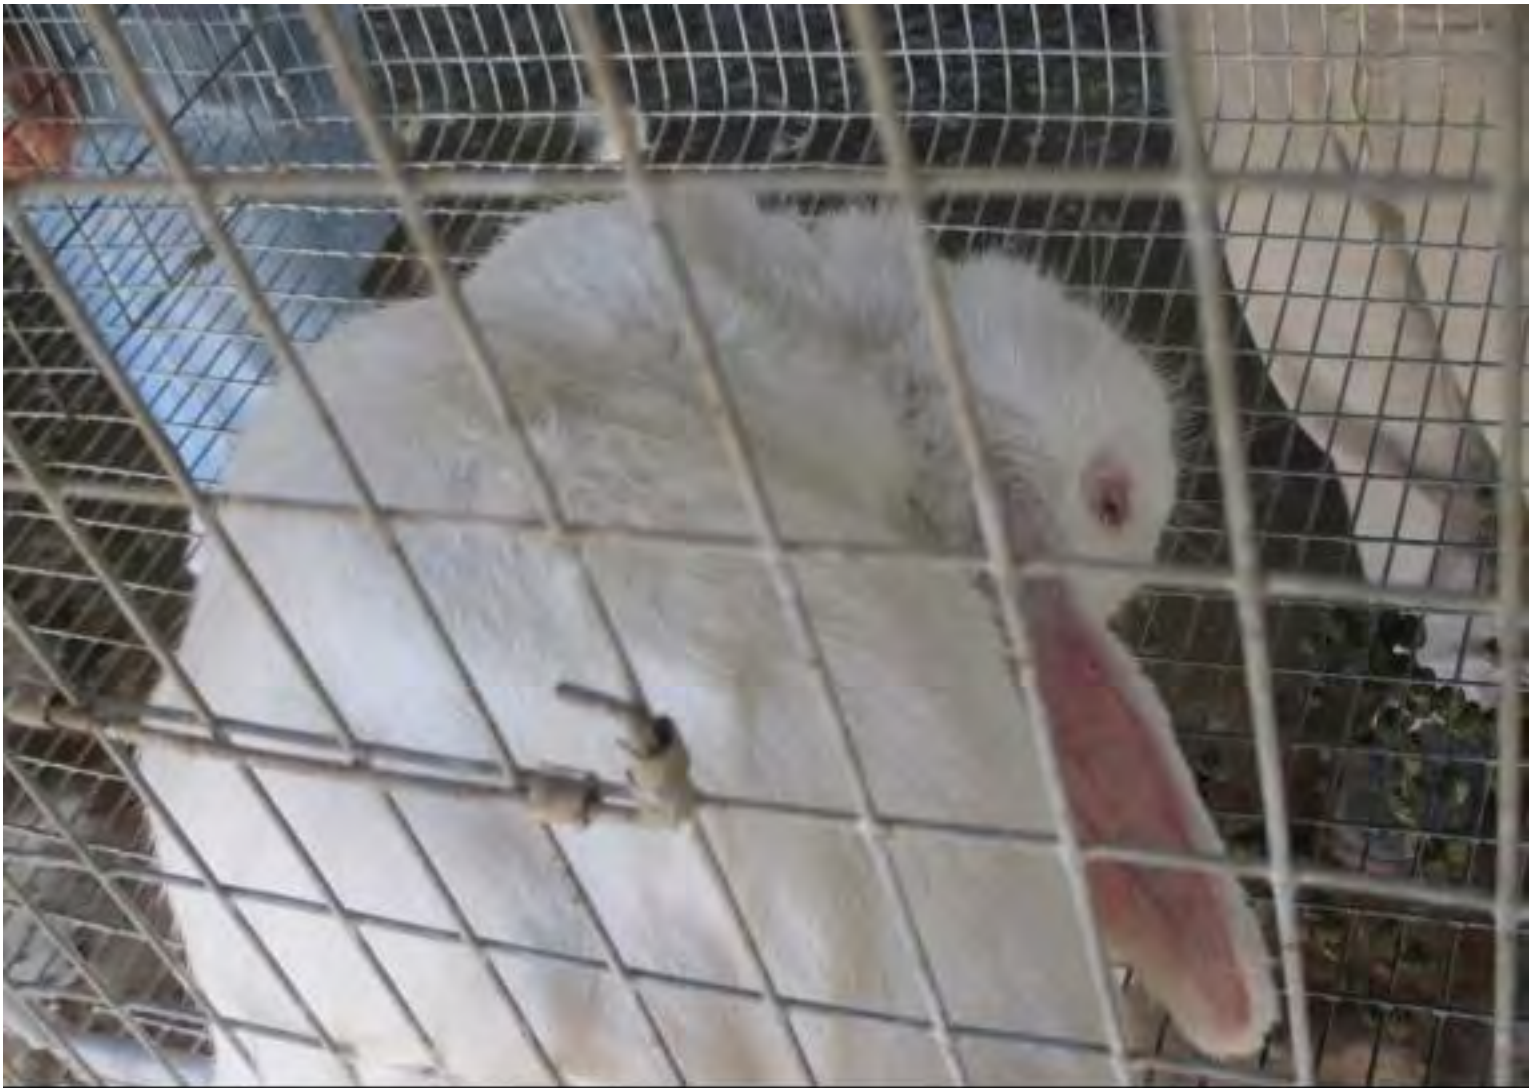
CFR: 2.33 (b) (2)

Photographer:	Tyler Fields	Legal Name:	93-R-0521
Photo Taken:	Wed, Jul 29, '15	PRO SCI INC.	
Inspection:	211151857550456		
Description:	Rabbit with a head tilt. Veterinary care is needed.

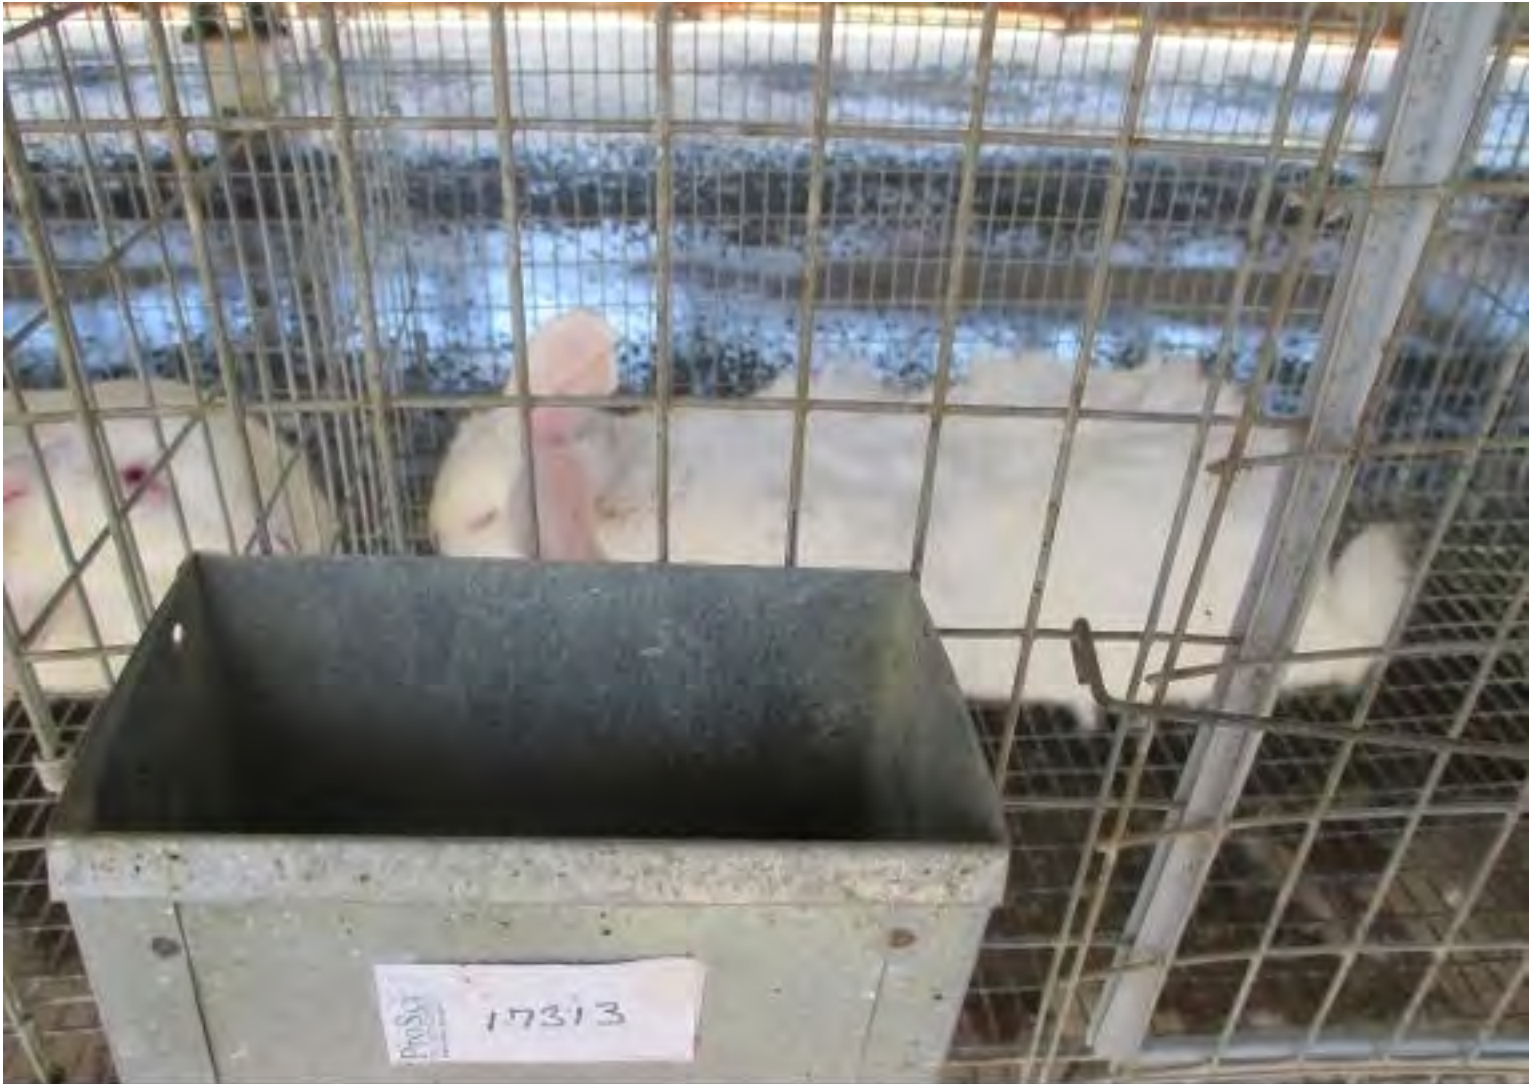
CFR: 2.33 (b) (2)

Photographer:	Tyler Fields	Legal Name:	93-R-0521
Photo Taken:	Wed, Jul 29, '15	PRO SCI INC.	
Inspection:	211151857550456		
Description:	Rabbit with a head tilt. Veterinary care is needed

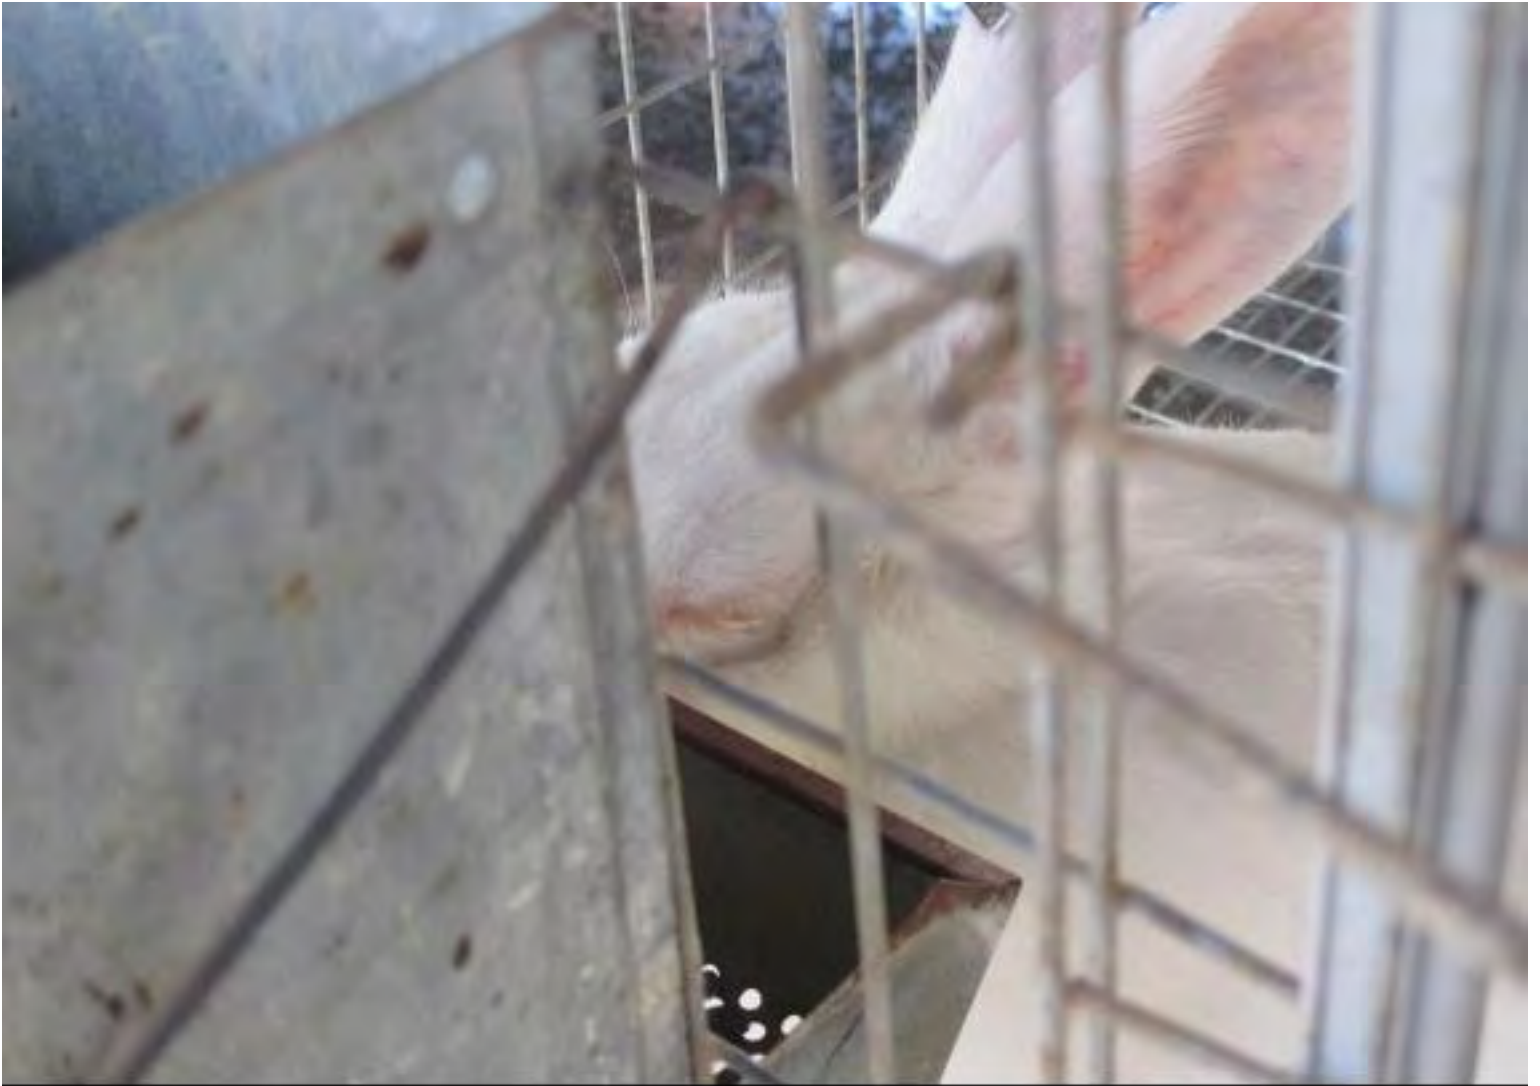
CFR: 2.33 (b) (2)

Photographer:	Tyler Fields	Legal Name:	93-R-0521
Photo Taken:	Wed, Jul 29, '15	PRO SCI INC.	
Inspection:	211151857550456		
Description:	Squinting and clear discharge is observed in left eye.

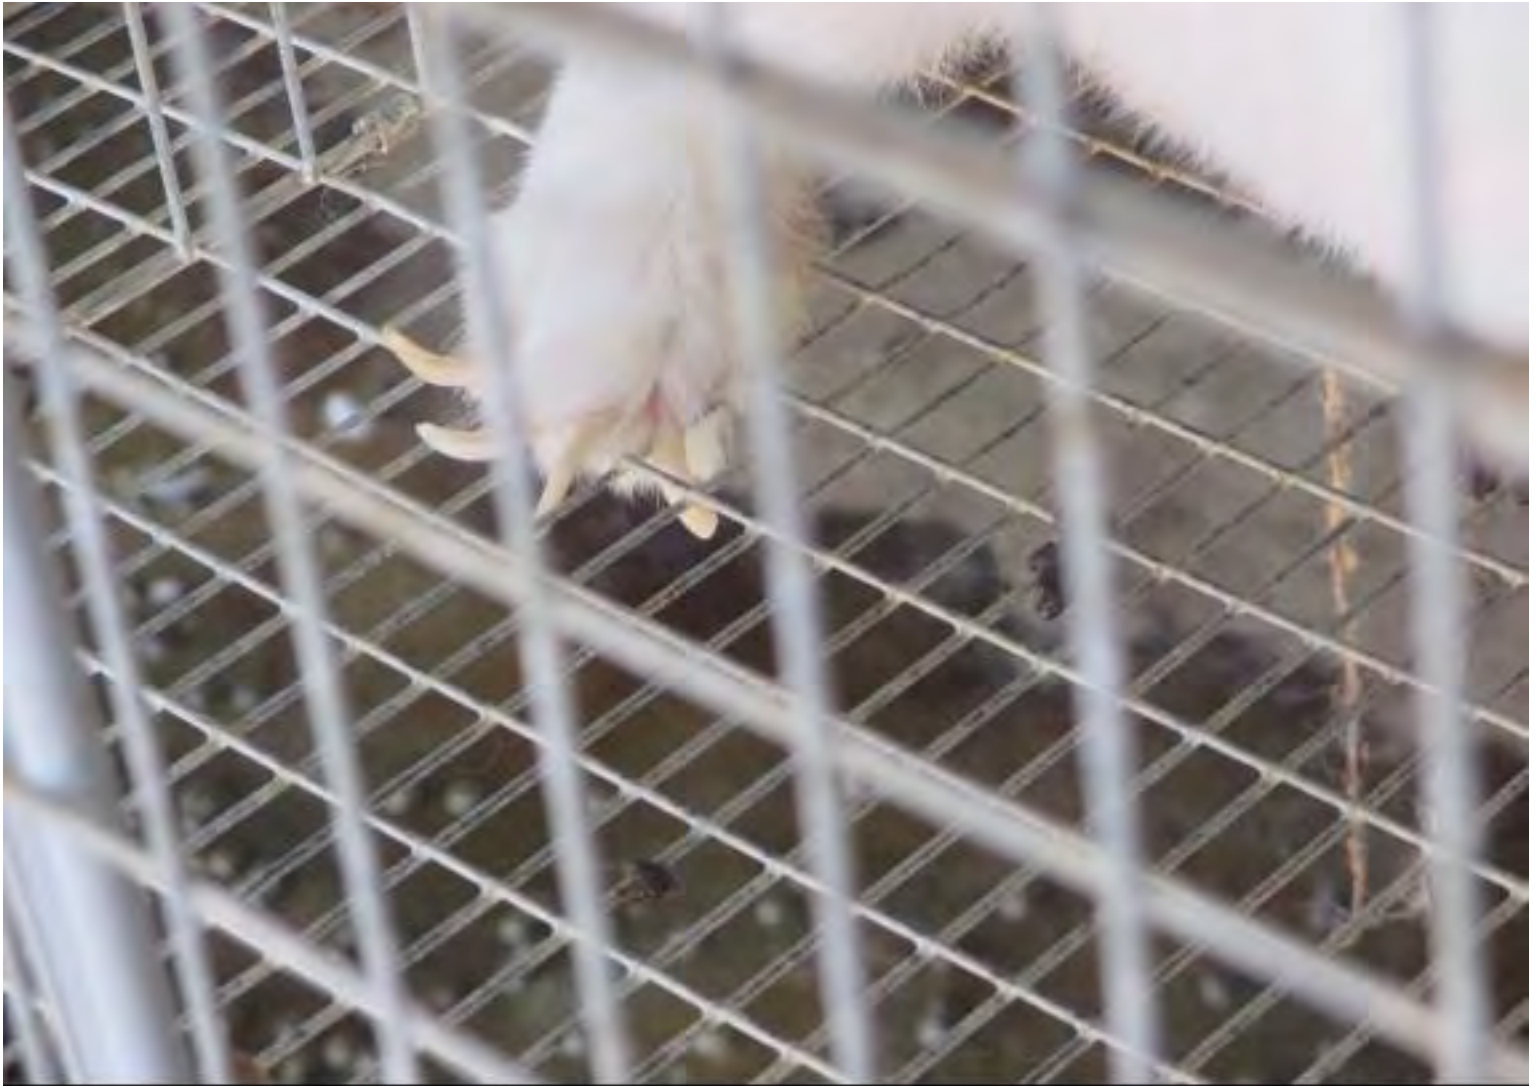
CFR: 2.33 (b) (2)

Photographer:	Tyler Fields	Legal Name:	93-R-0521
Photo Taken:	Wed, Jul 29, '15	PRO SCI INC.	
Inspection:	211151857550456		
Description:	Rabbit with overgrown nails
