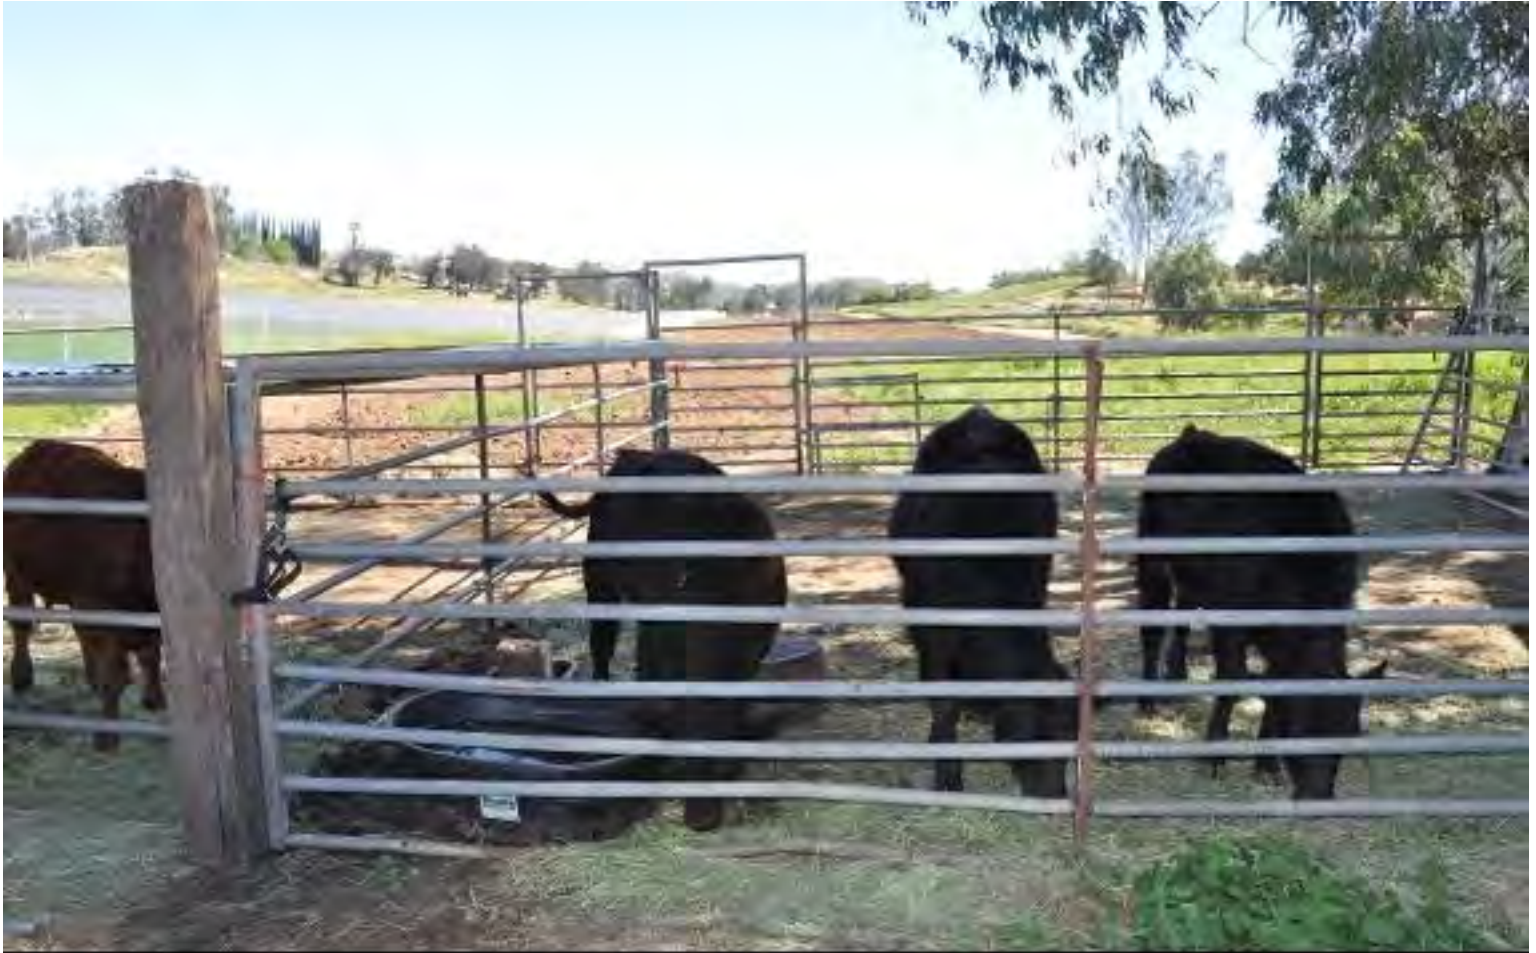
CFR: 3.127 (a)

Photographer:	Legal Name:	93-R-0521
Photo Taken: Wed, Mar 23, '16	Pro Sci Inc.	
Inspection: 91161649010644		
Description: One shade structure(approx.3ft.X 6 ft.) not sufficiently sized for 4 cows to comfortably protect all animals from the direct rays of sun.

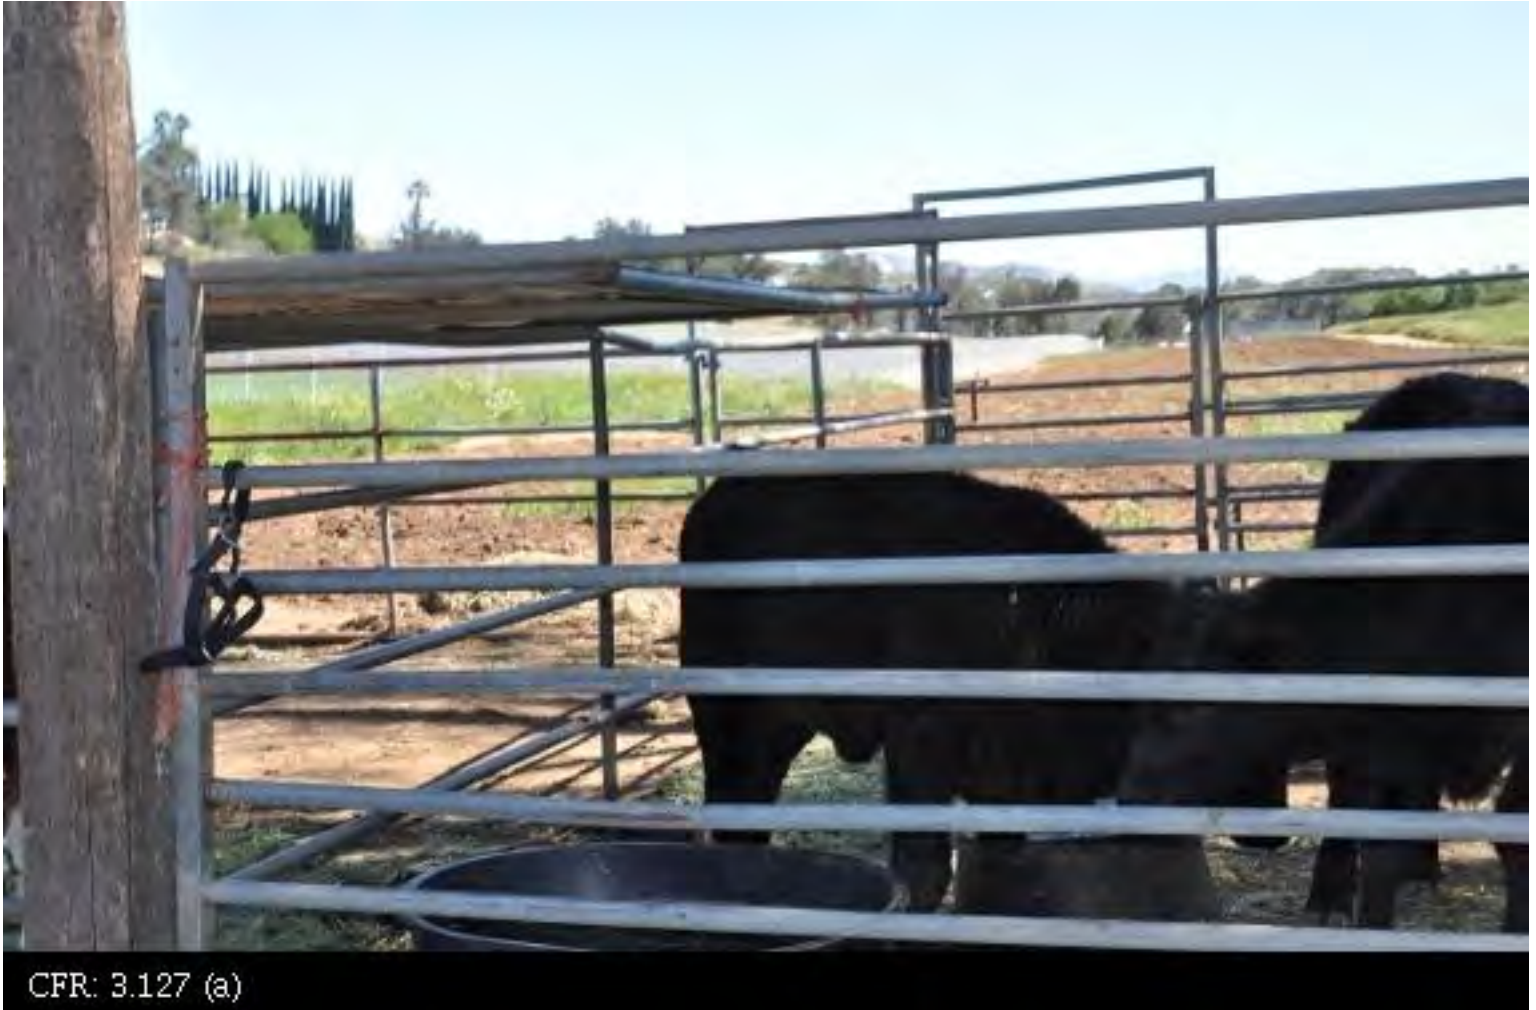
Photographer:	Legal Name:	93-R-0521
Photo Taken: Wed, Mar 23, '16	Pro Sci Inc.	
Inspection: 91161649010644		
Description: One shade structure(approx.3ft.X 6 ft.) not sufficiently sized for 4 cows to comfortably protect all animals from the direct rays of sun.

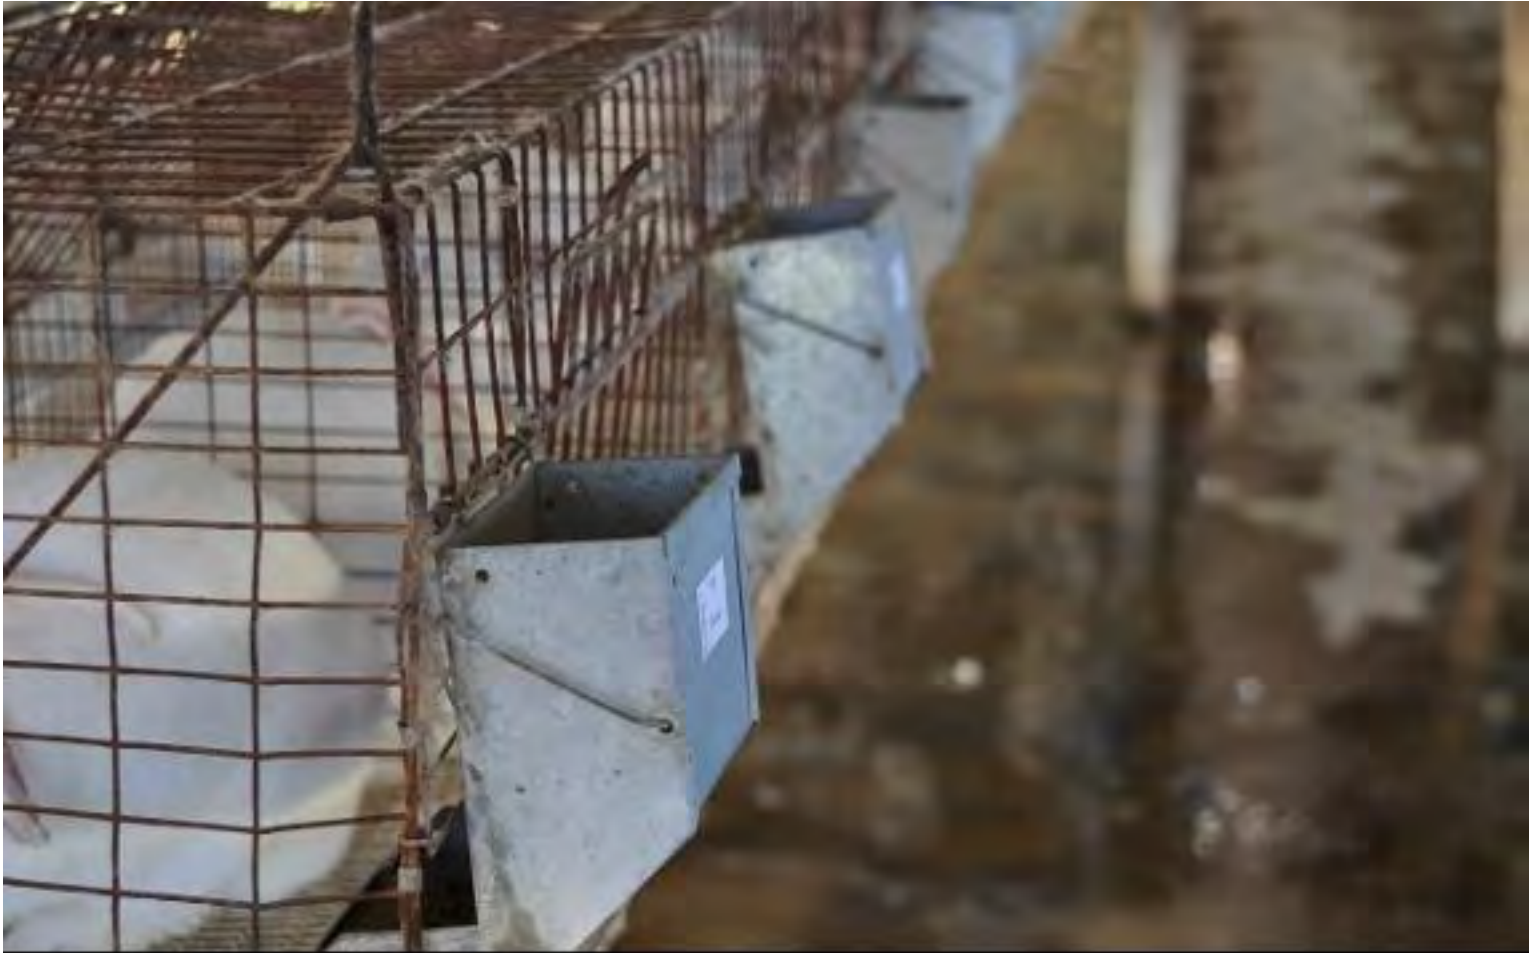
CFR: 3.51 (d)

Photographer:	Legal Name:	93-R-0521
Photo Taken: Wed, Mar 23, '16	Pro Sci Inc.	
Inspection: 91161649010644		
Description: Repeat: Rabbit cages moderately covered in rust. Rust may prevent the required cleaning and sanitization.

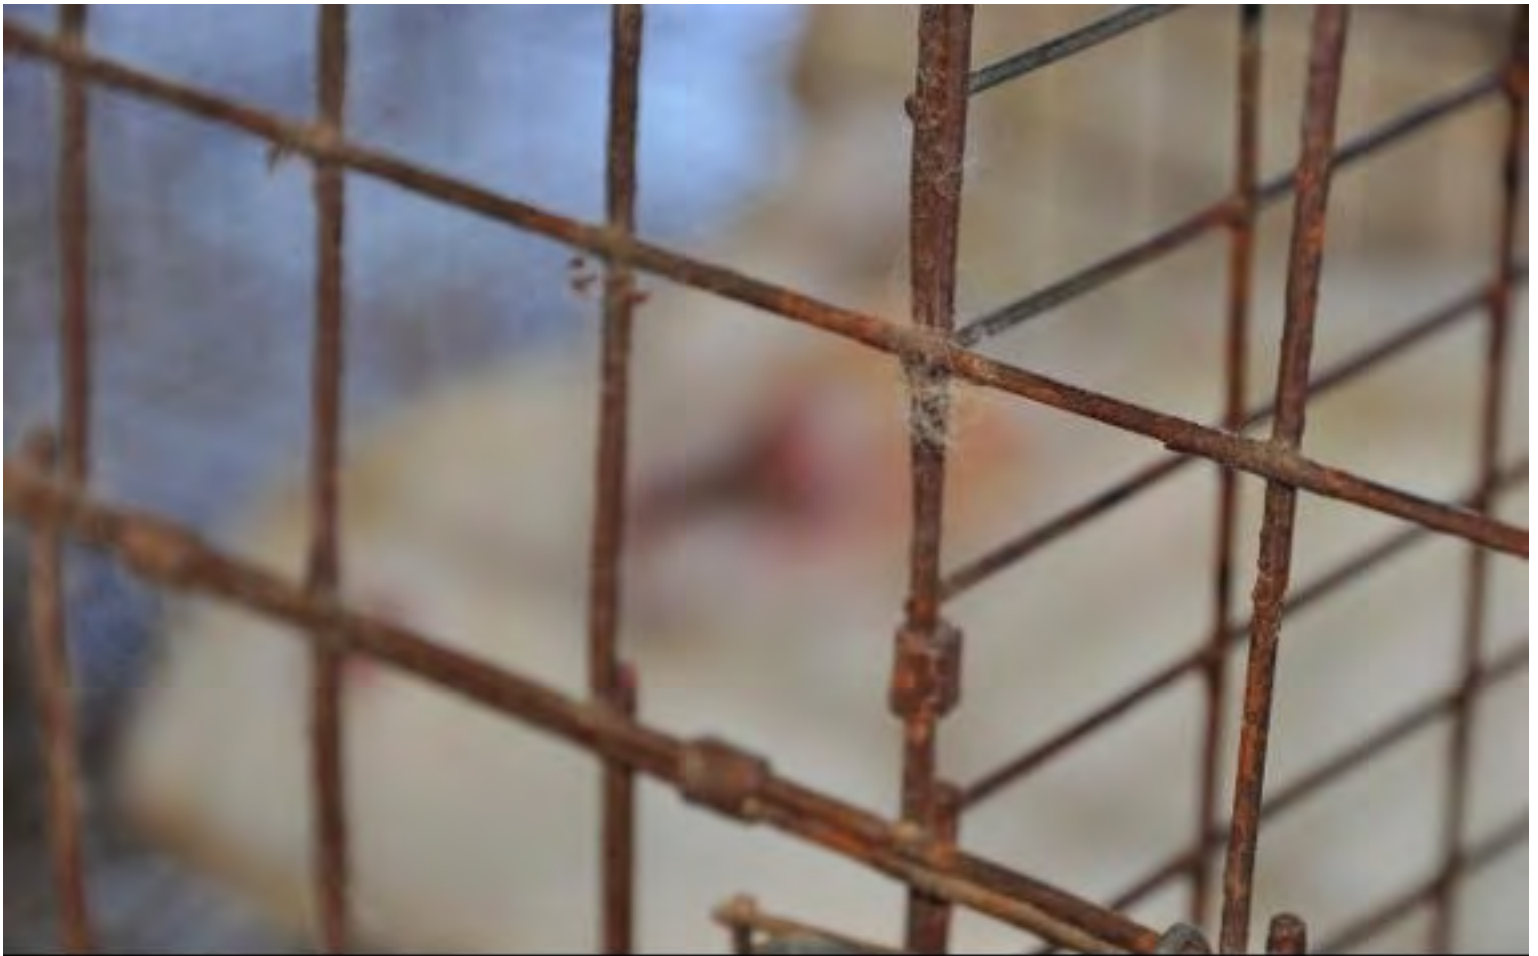
CFR: 3.51 (d)

Photographer:	Legal Name:	93-R-0521
Photo Taken: Wed, Mar 23, '16	Pro Sci Inc.	
Inspection: 91161649010644		
Description: Repeat: Rabbit cages moderately covered in rust. Rust may prevent the required cleaning and sanitization.(close up)

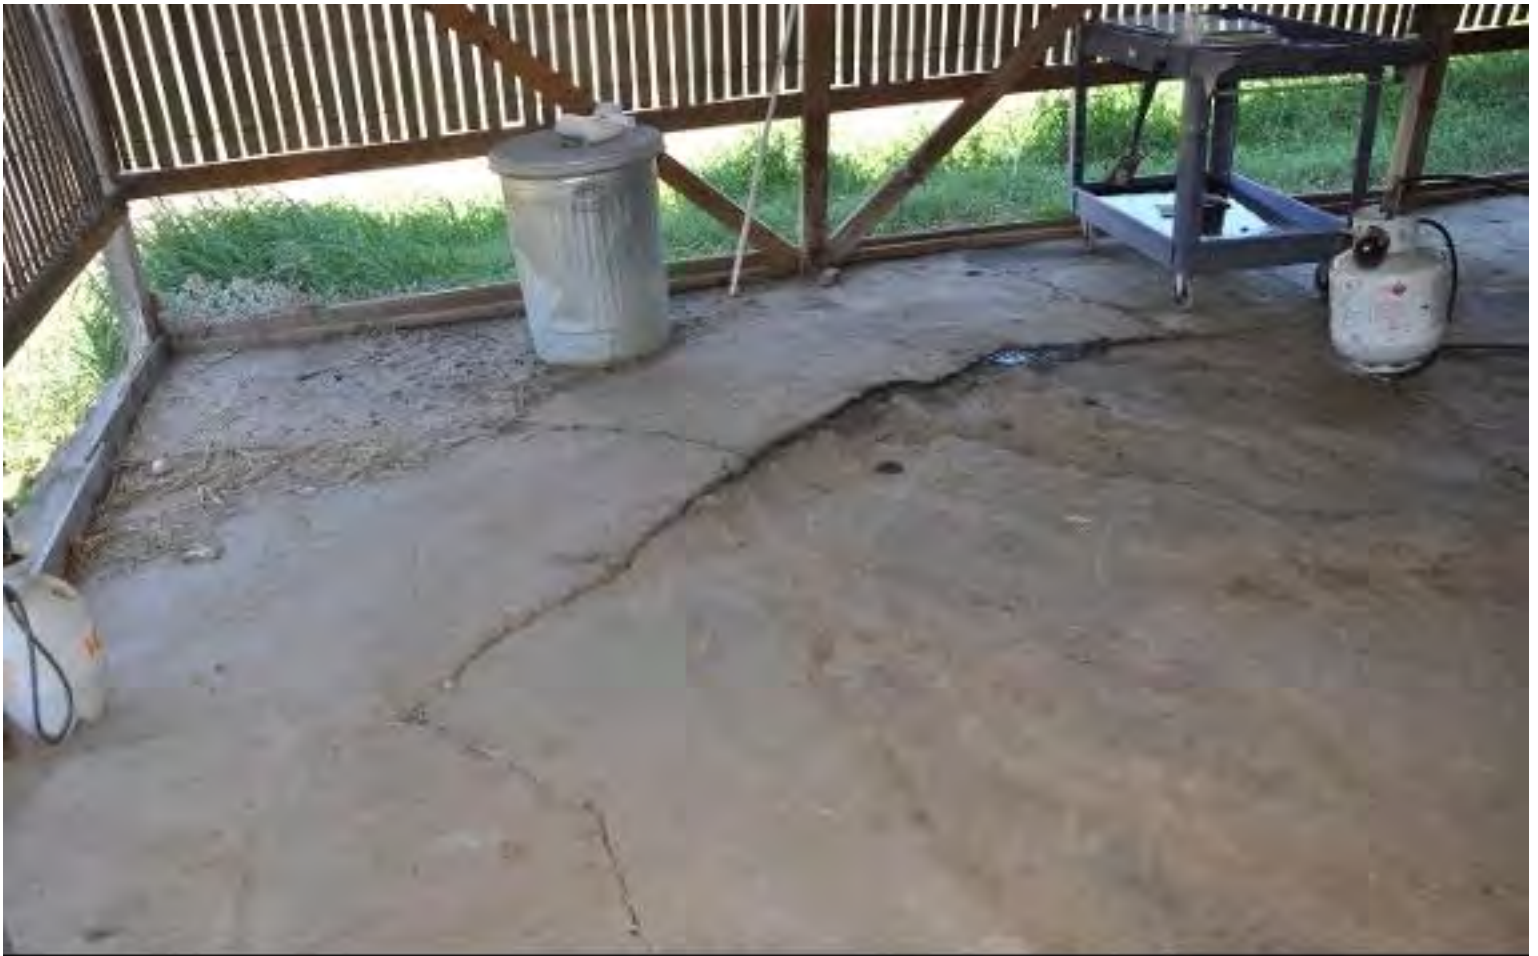
CFR: 3.51 (d)

Photographer:	Legal Name:	93-R-0521
Photo Taken: Wed, Mar 23, '16	Pro Sci Inc.	
Inspection: 91161649010644		
Description: Rabbit barn: a large crack approx. 5-6 feet long in cement floor. Large cracks are not impervious to moisture and may prevent proper sanitization.

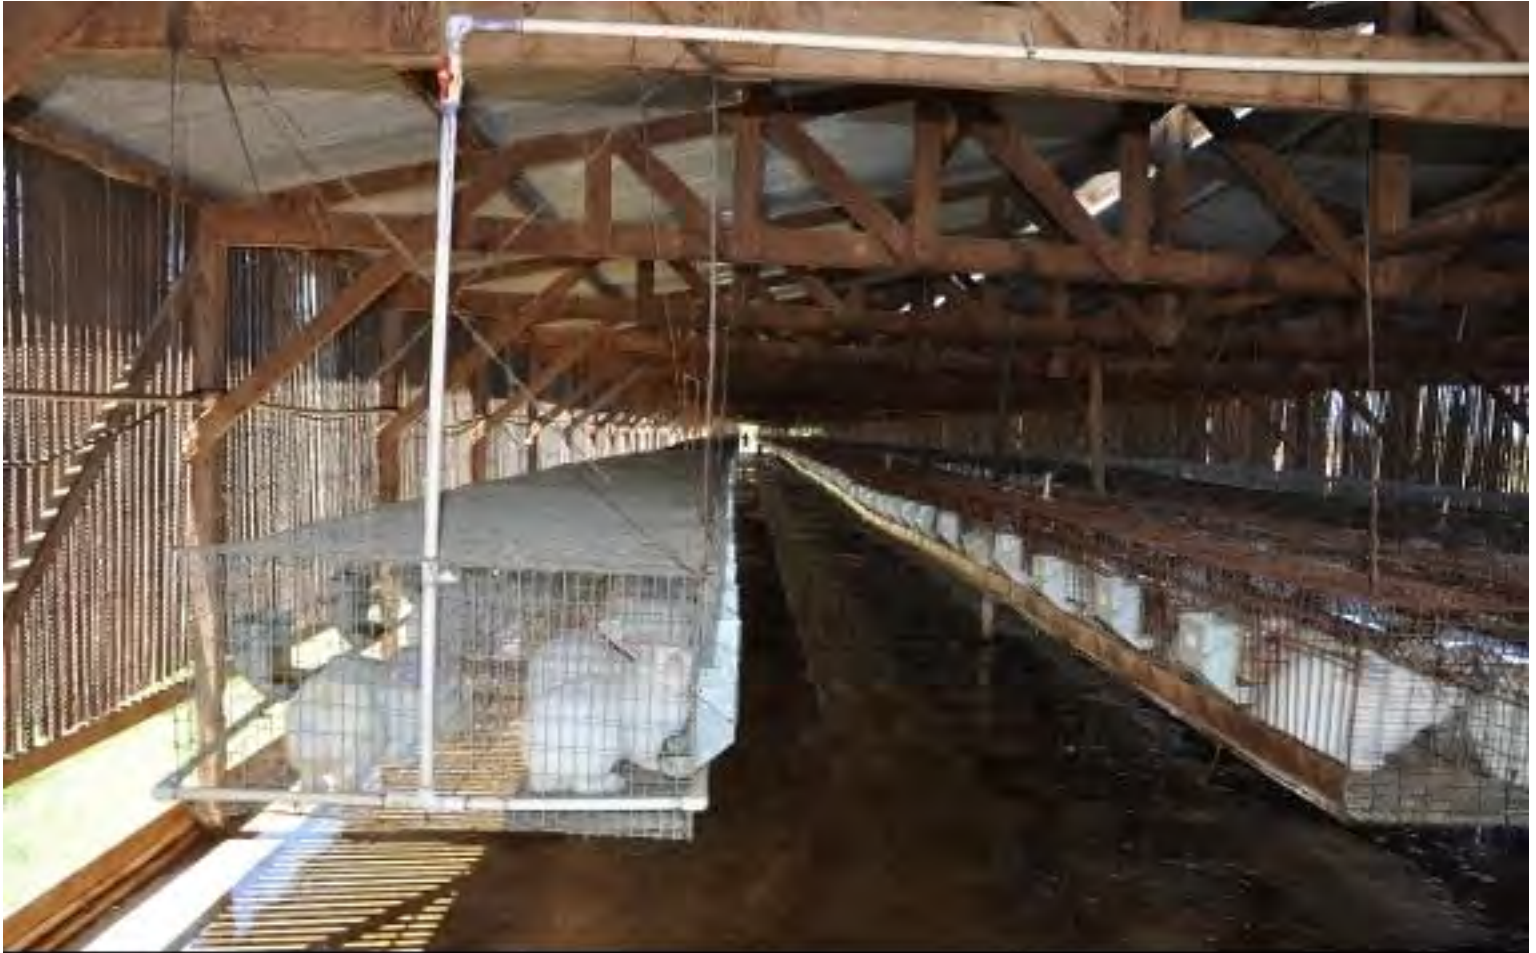
CFR: 3.53 (c) (2), 3.51 (d)

Description: Row of rabbit cages with moderate rust. Also, some rabbit cages do not meet minimum space requirements for rabbits over 8.8 lbs.

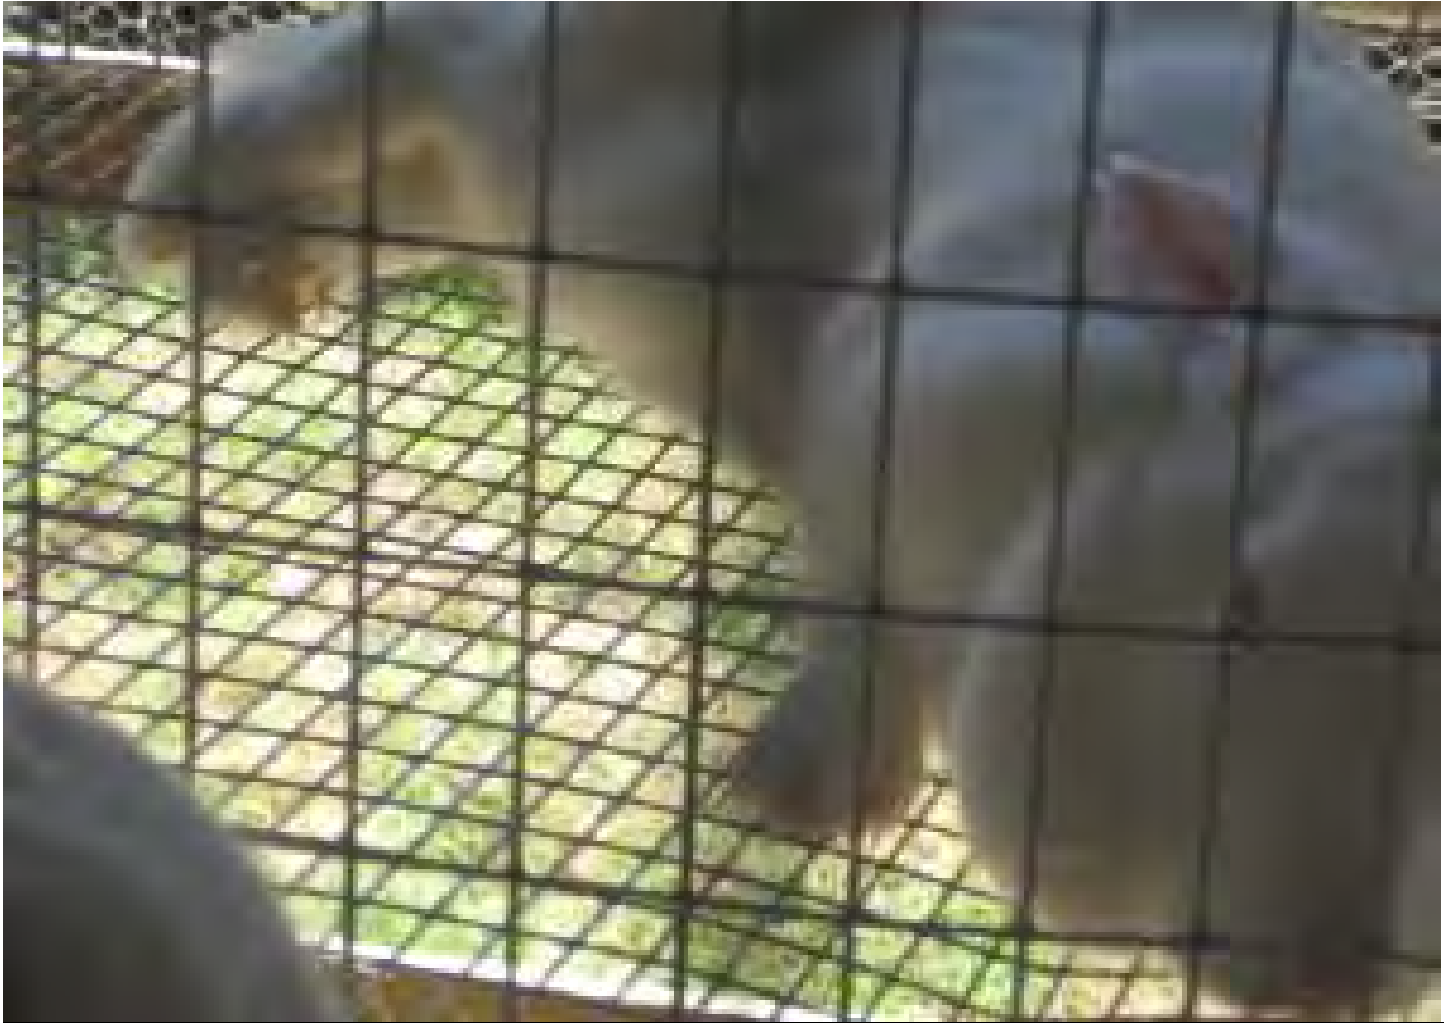
CFR : 2.33(b)(2)

Example of rabbit with overgrown nails; front and back feet.

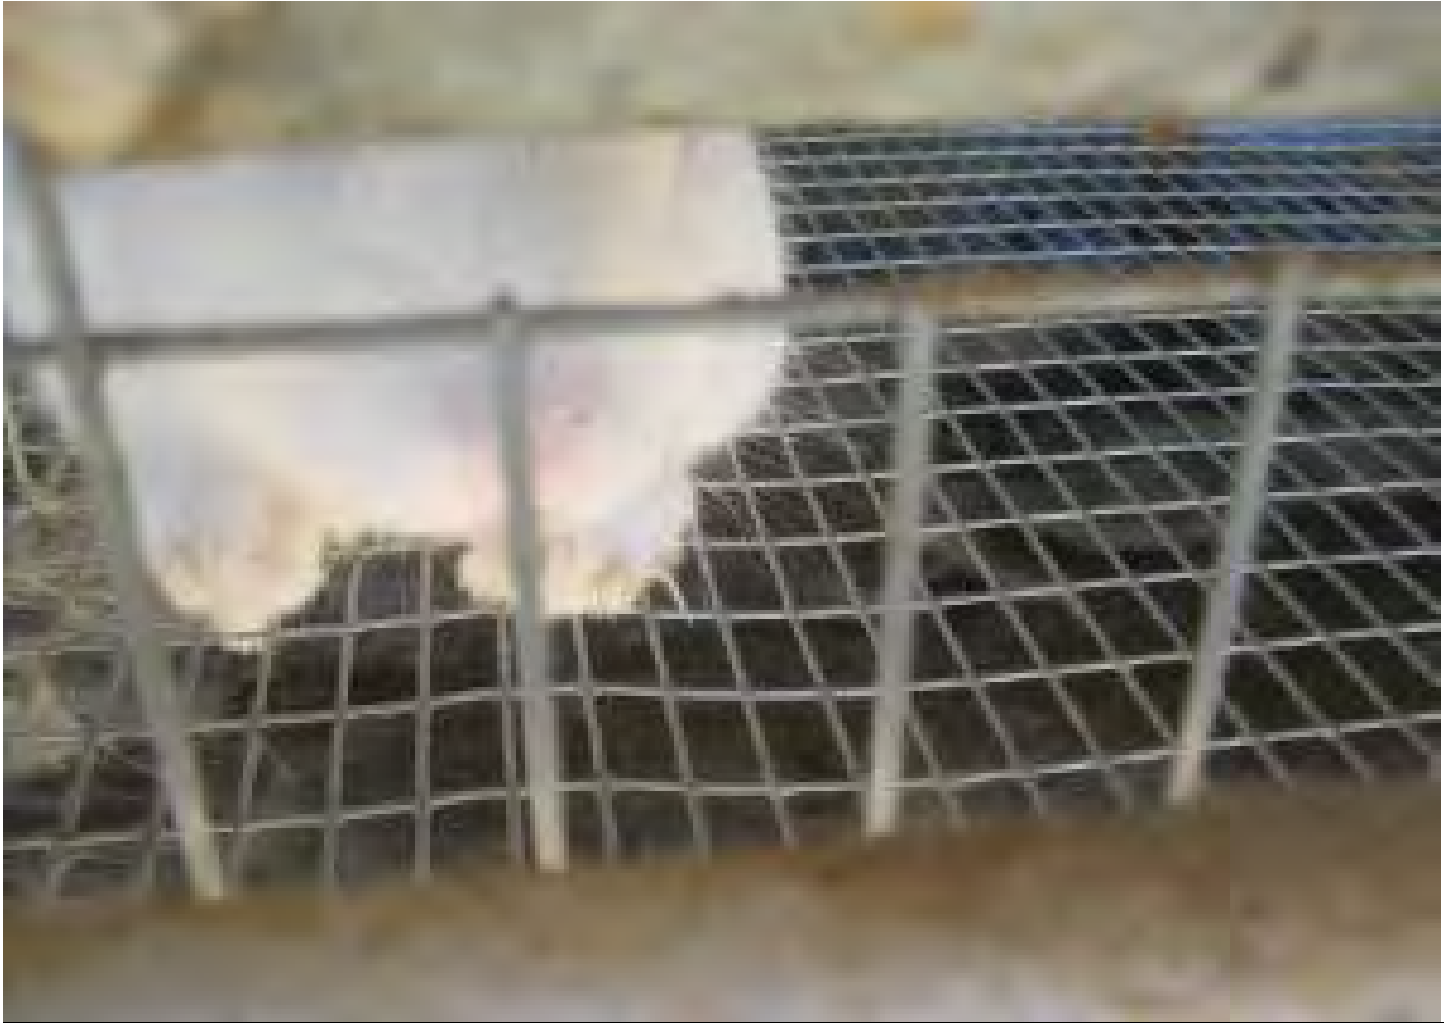
CFR : 2.33(b)(2)

Example of rabbit with overgrown nails; front feet.

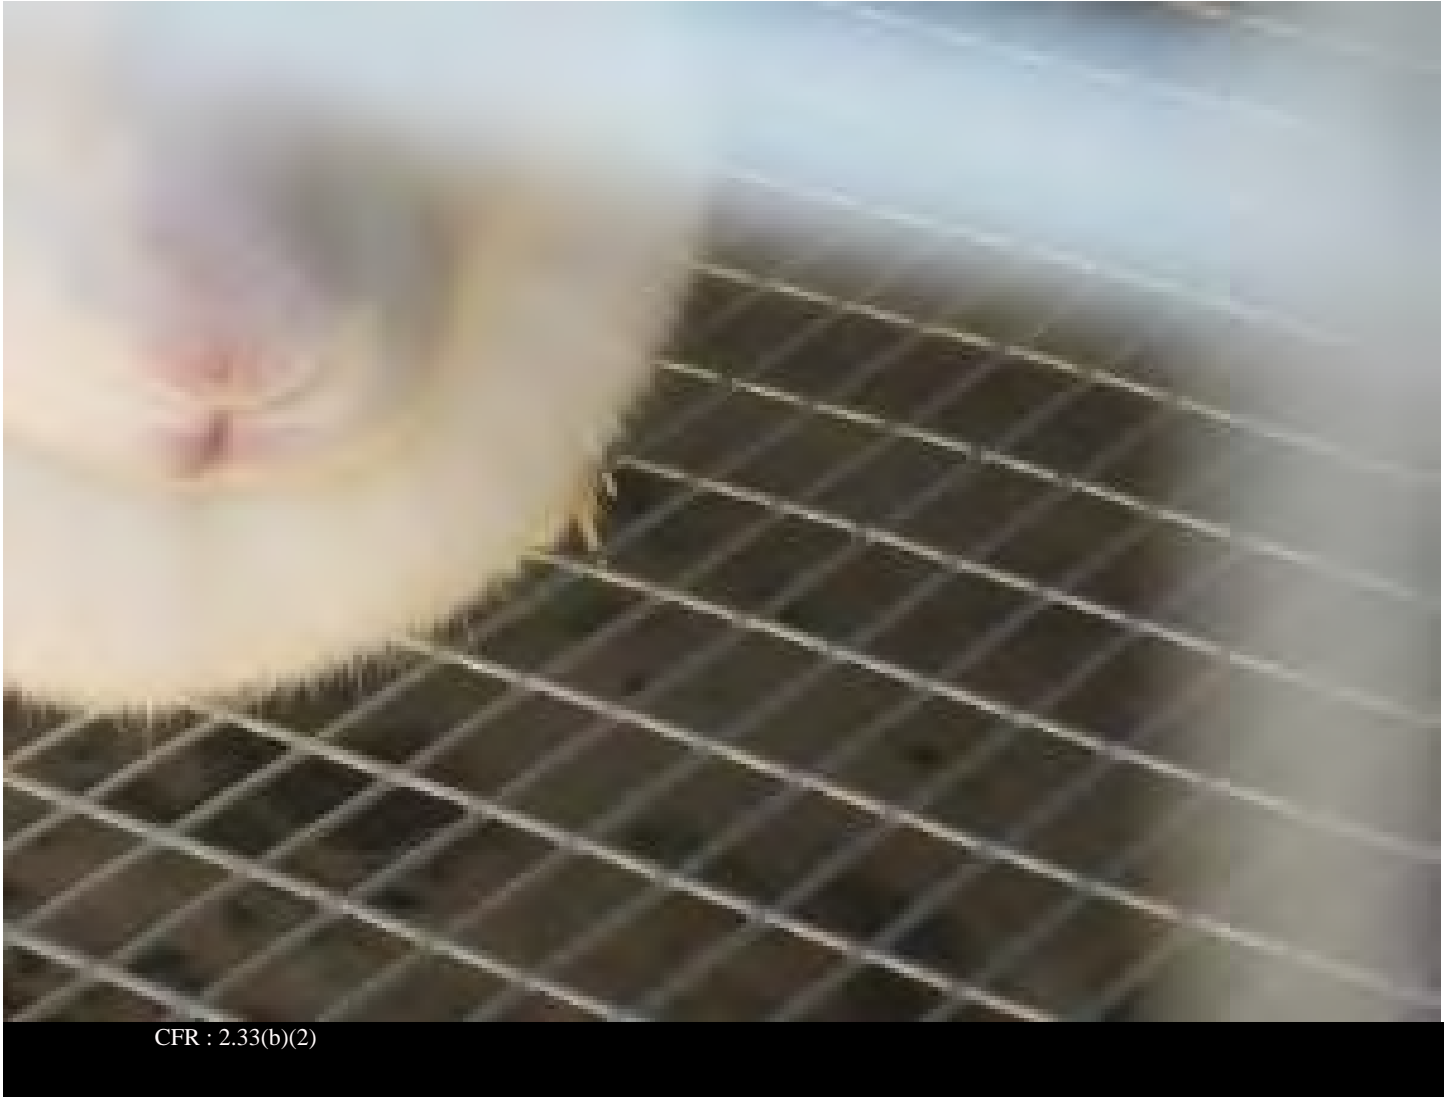
CFR : 2.33(b)(2)

Example of rabbit with overgrown nails; front left foot.

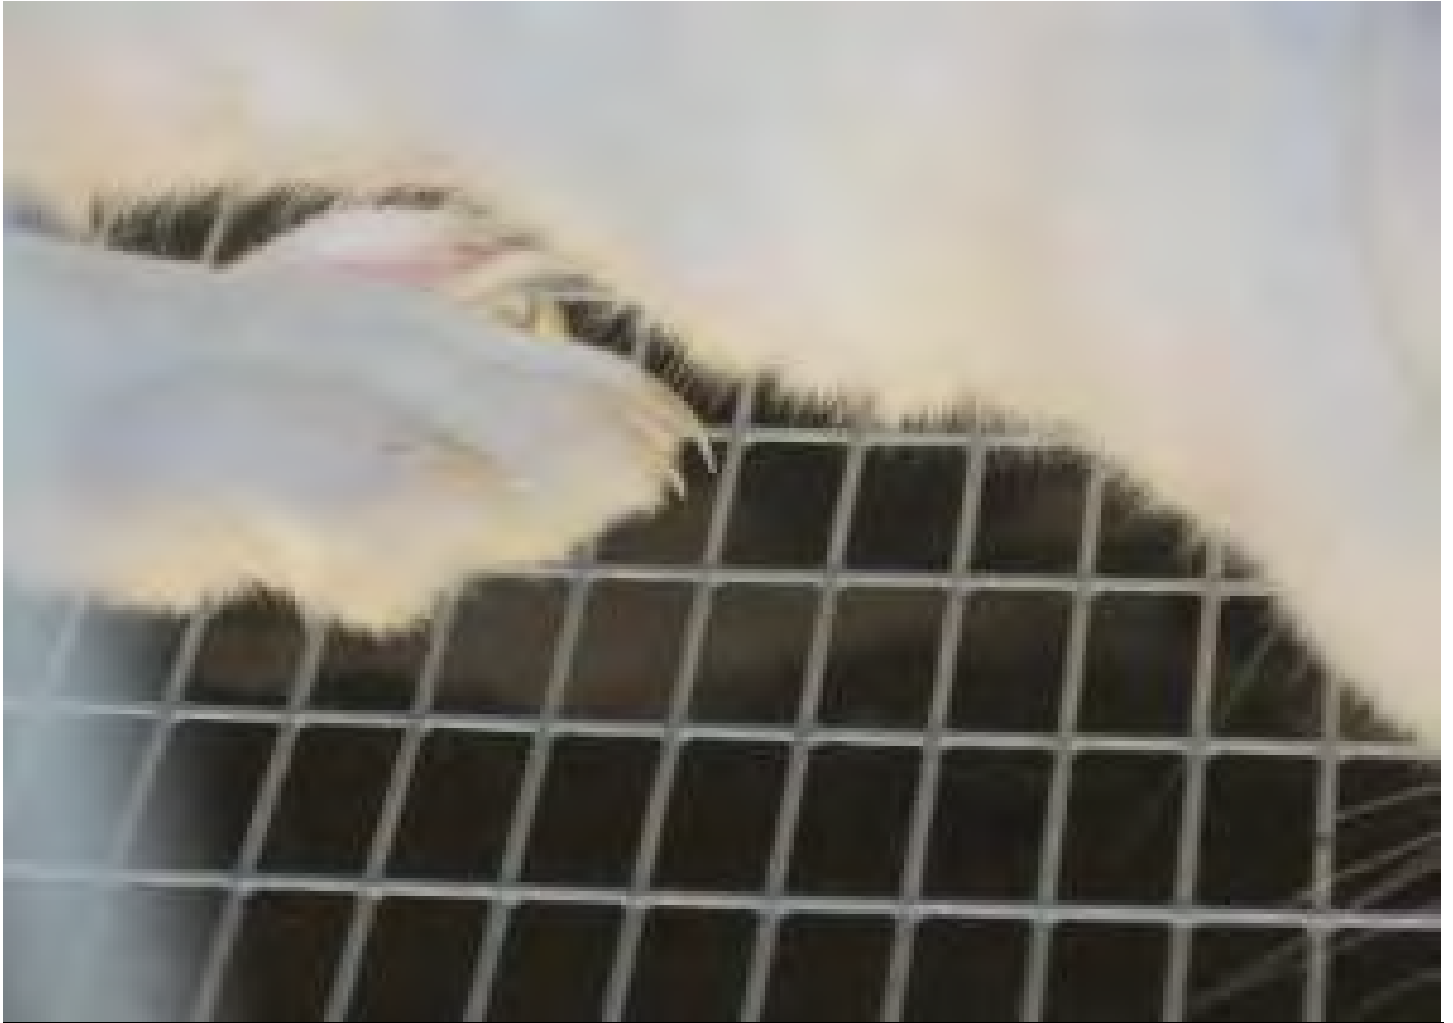
CFR : 2.33(b)(2)

Example of rabbit with overgrown nails; back right foot.

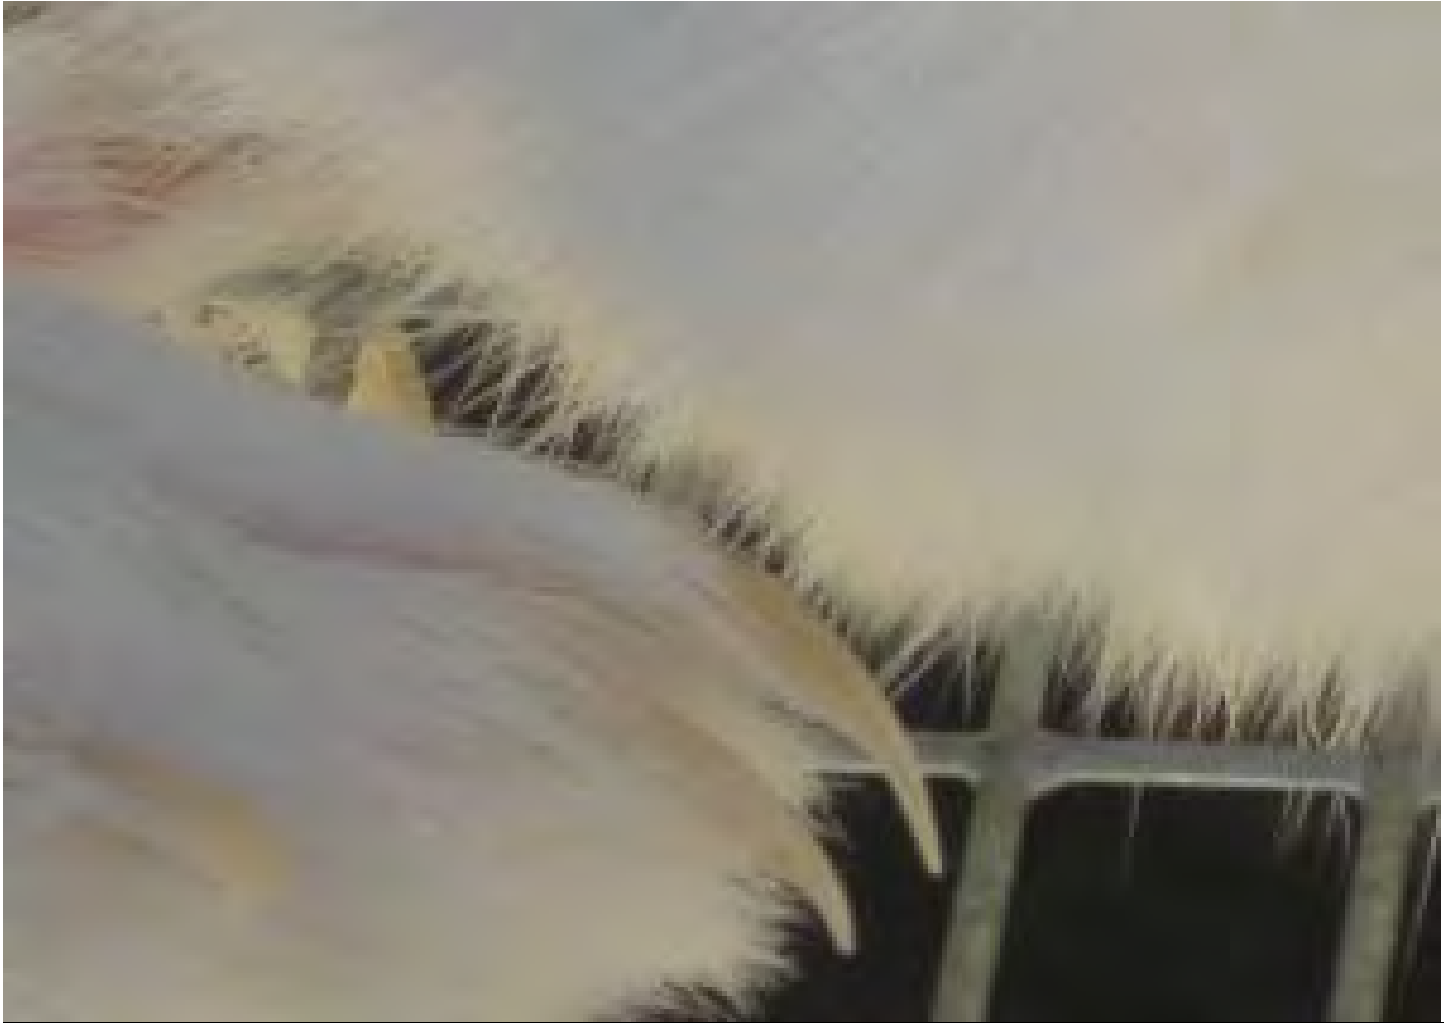
CFR : 2.33(b)(2)

Example of rabbit with overgrown nails; back right foot, close-up view.

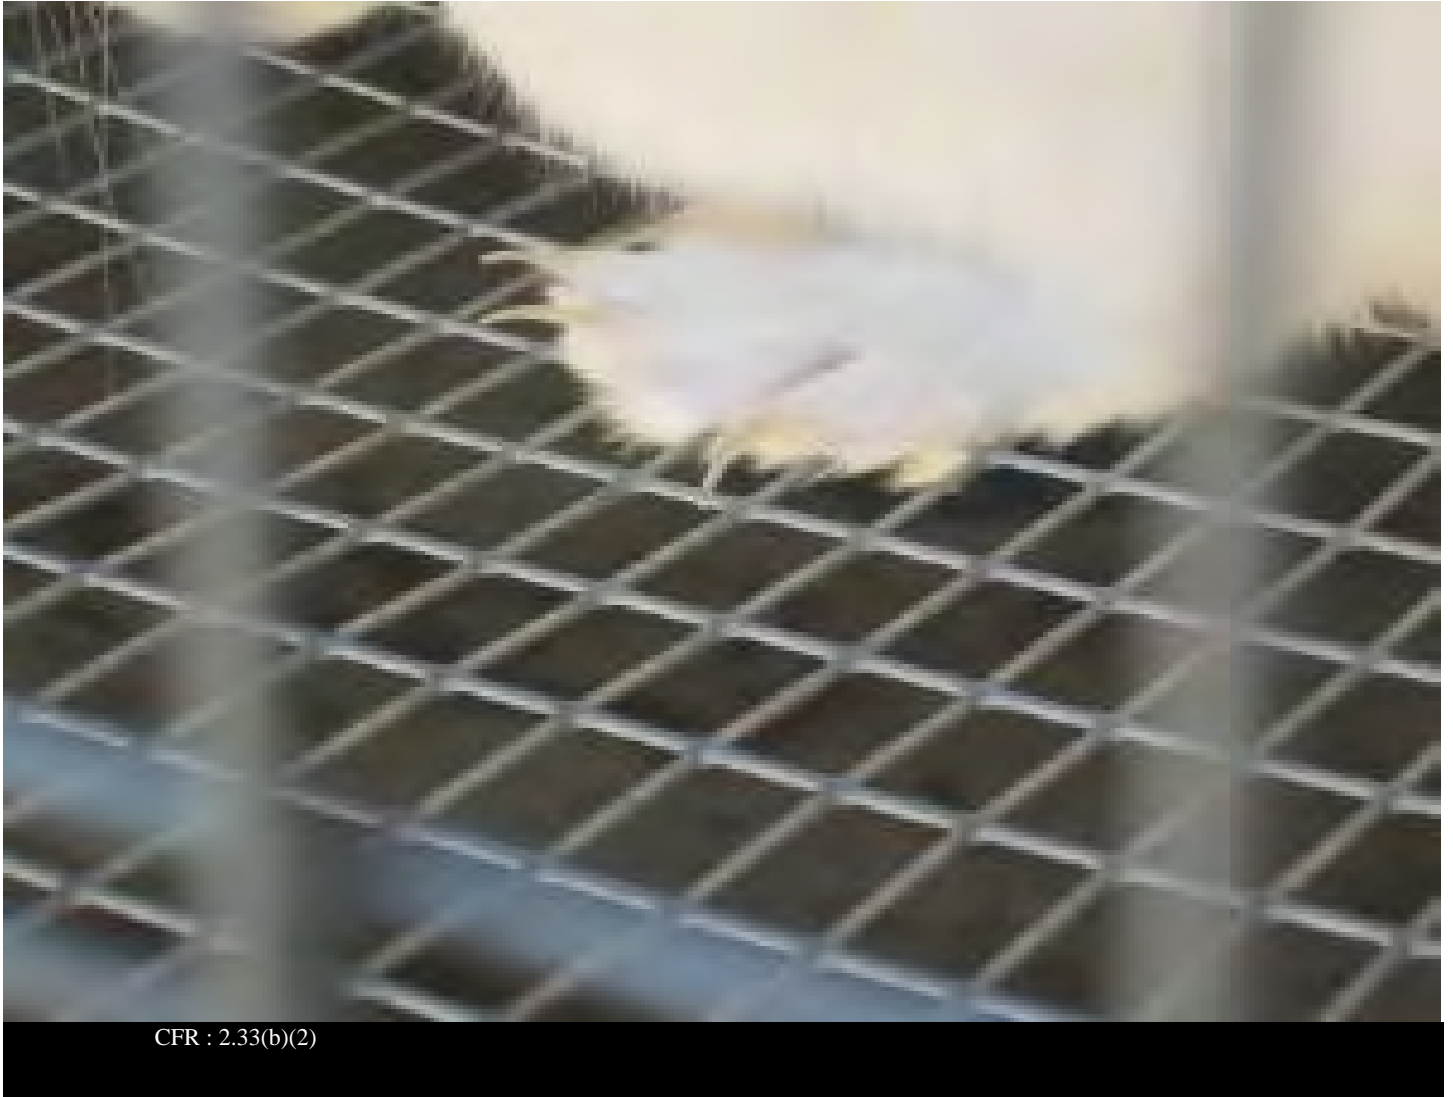
CFR : 2.33(b)(2)

Example of rabbit with overgrown nails; back left foot.

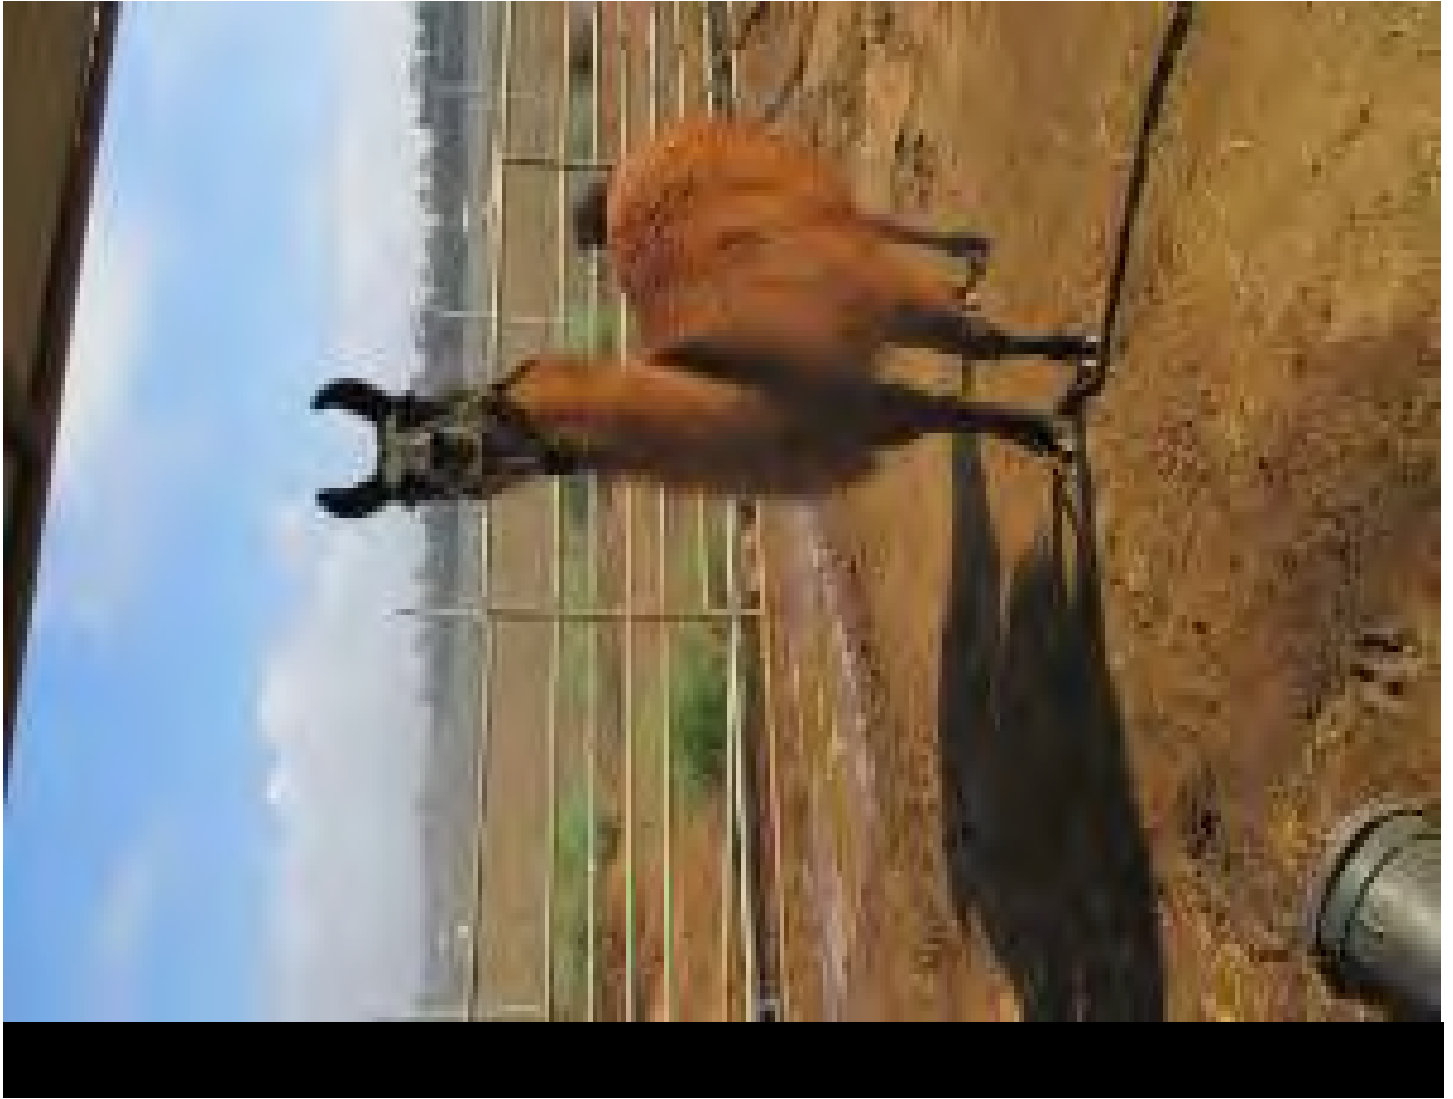
llama (next to cow pen) wearing long lead line that can entangle feet.

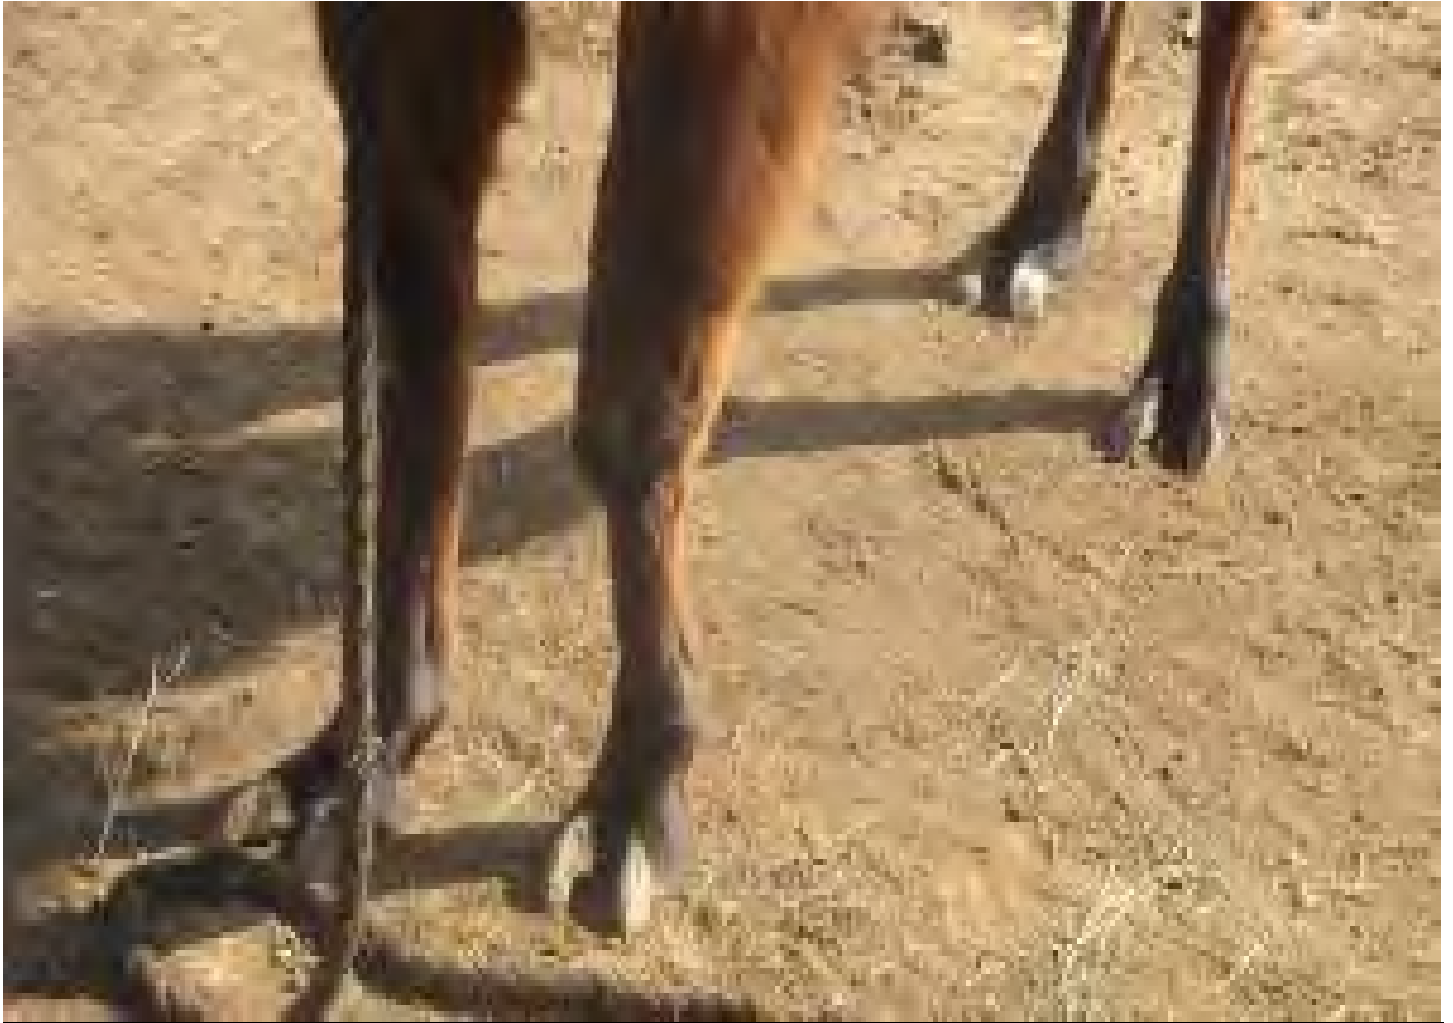
CFR : 2.131(b)(1) CFR : 2.33(b)(2)

llama (next to cow pen) wearing long lead line that can entangle feet. Excessively long hooves on a llama.

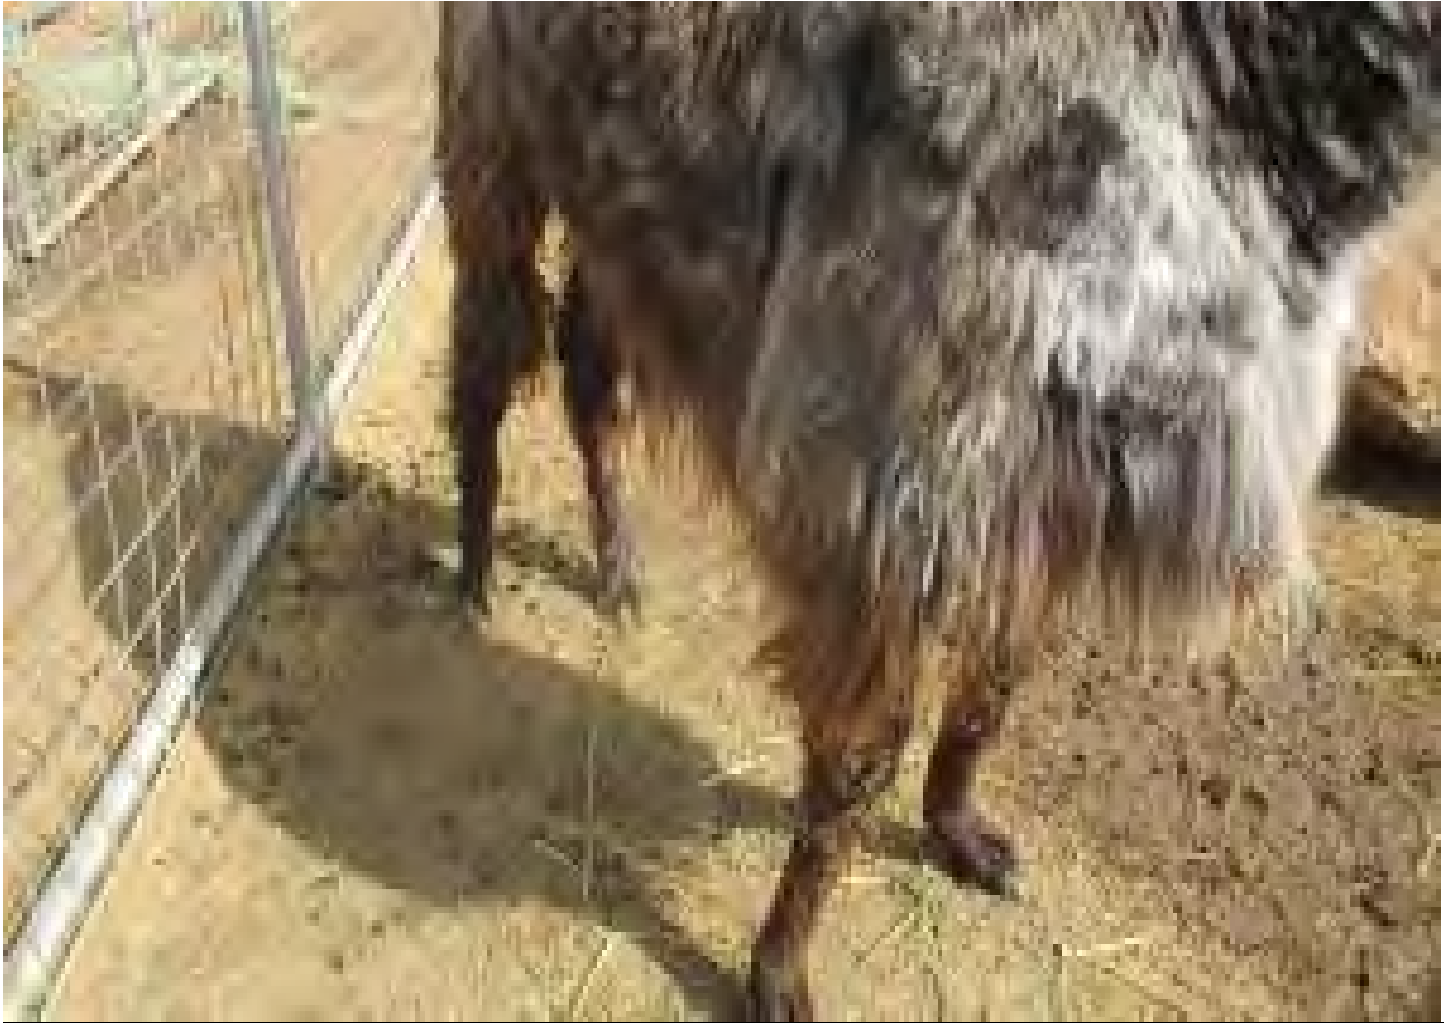
CFR : 2.33(b)(2)

Llama in goat pen with excessively long hooves.
