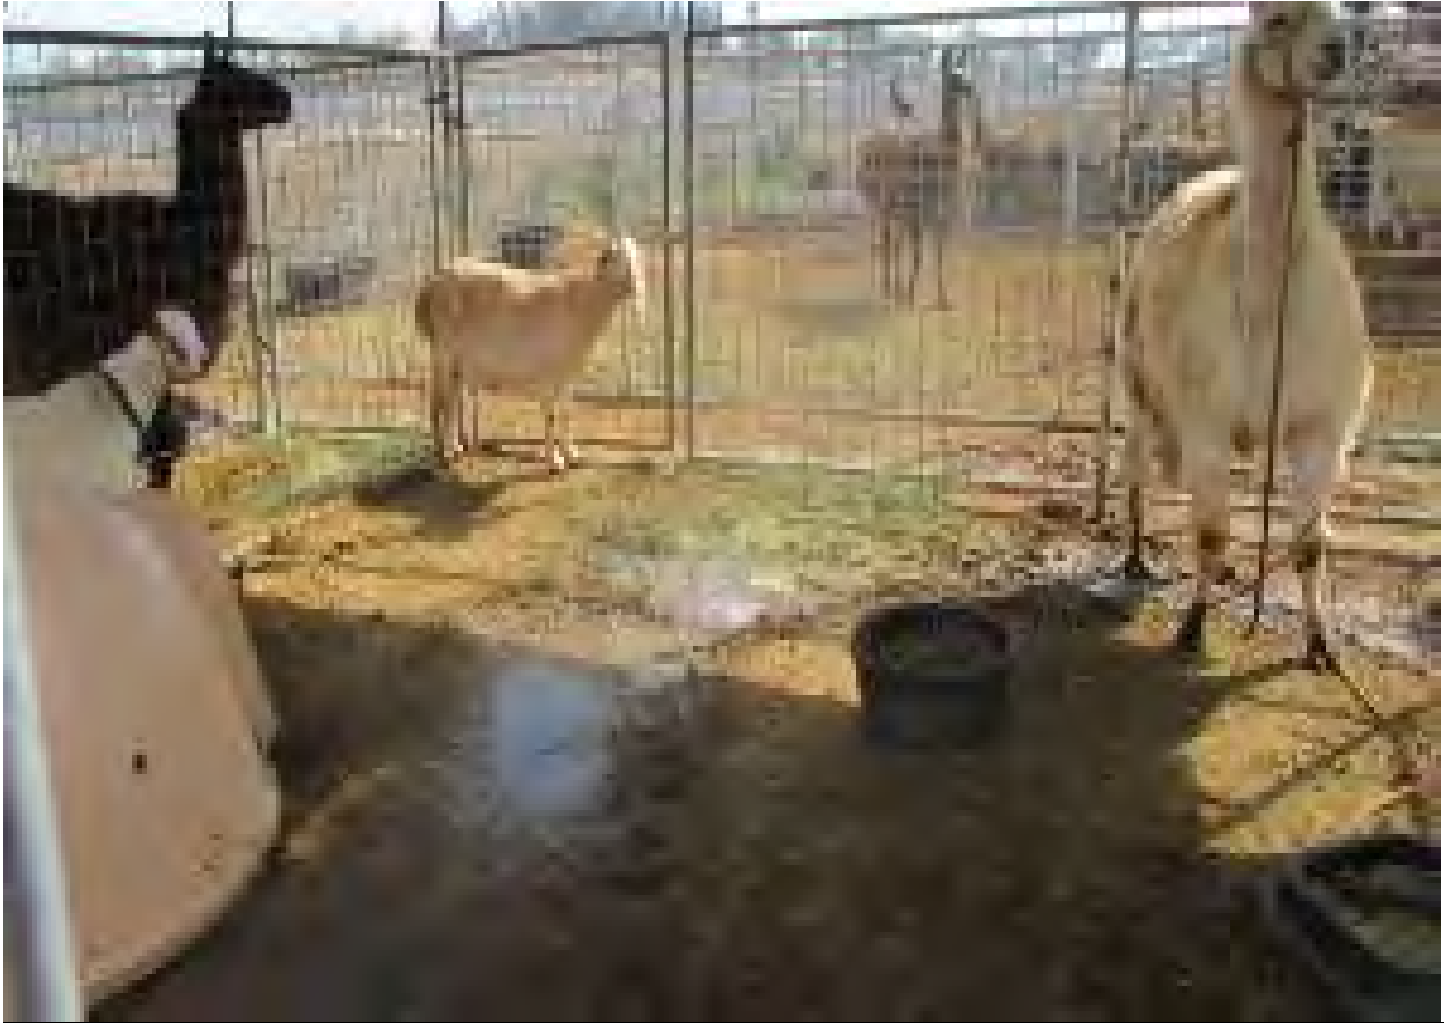
CFR : 2.131(b)(1)

llama wearing long lead line that can entangle feet. Lasso also left in the enclosure.

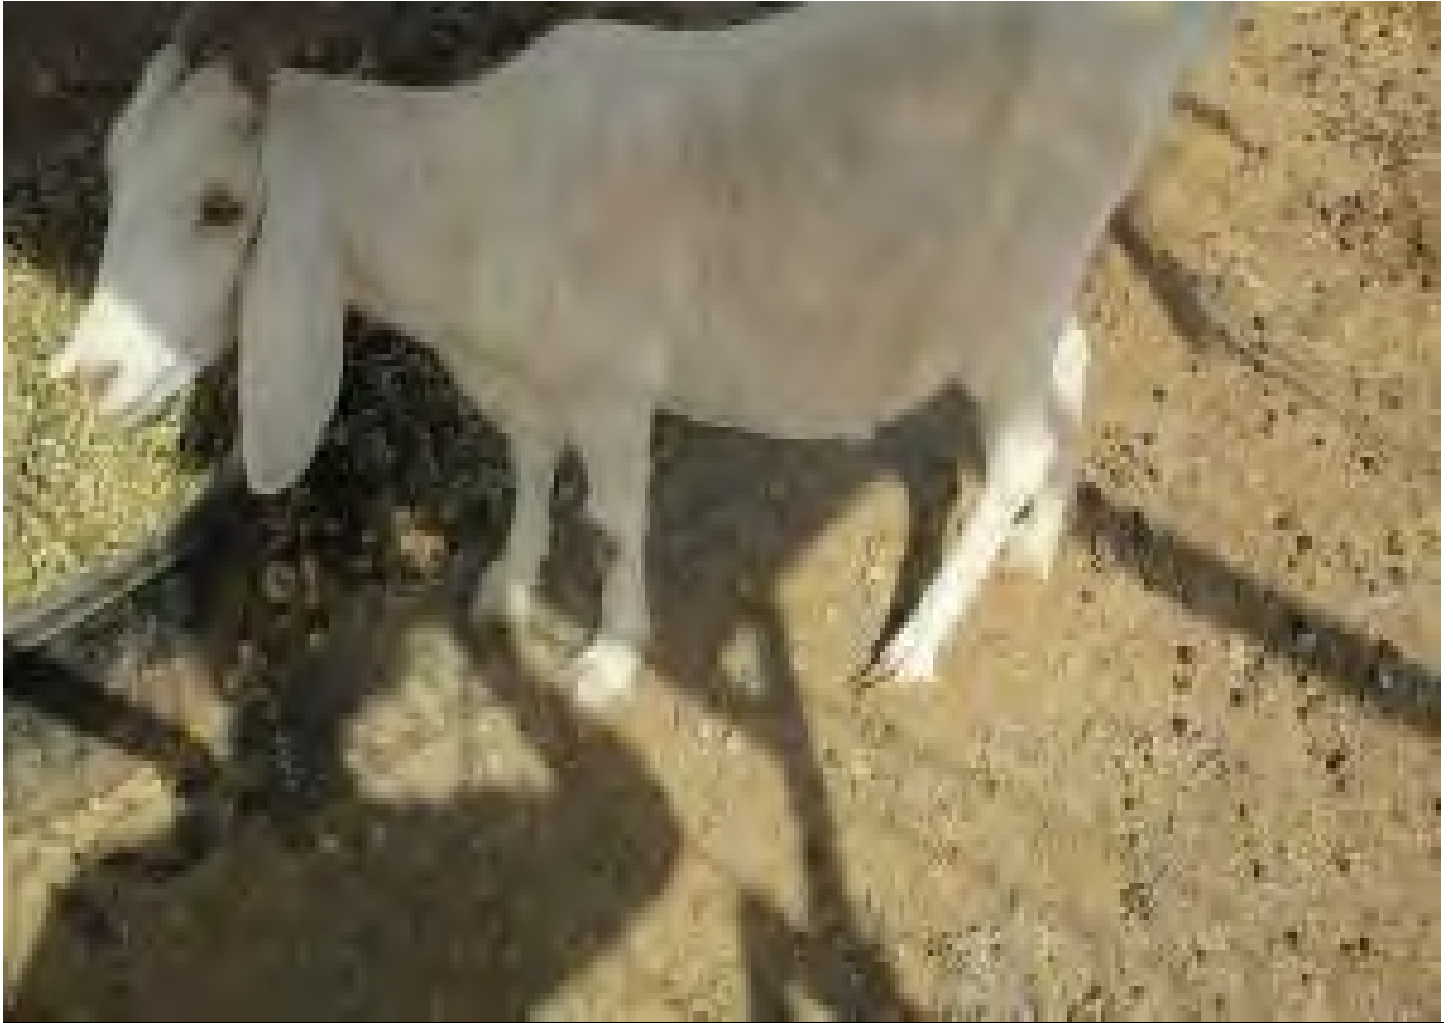
CFR : 2.33(b)(2)

Excessively long hooves in a goat in the quarantine pens.

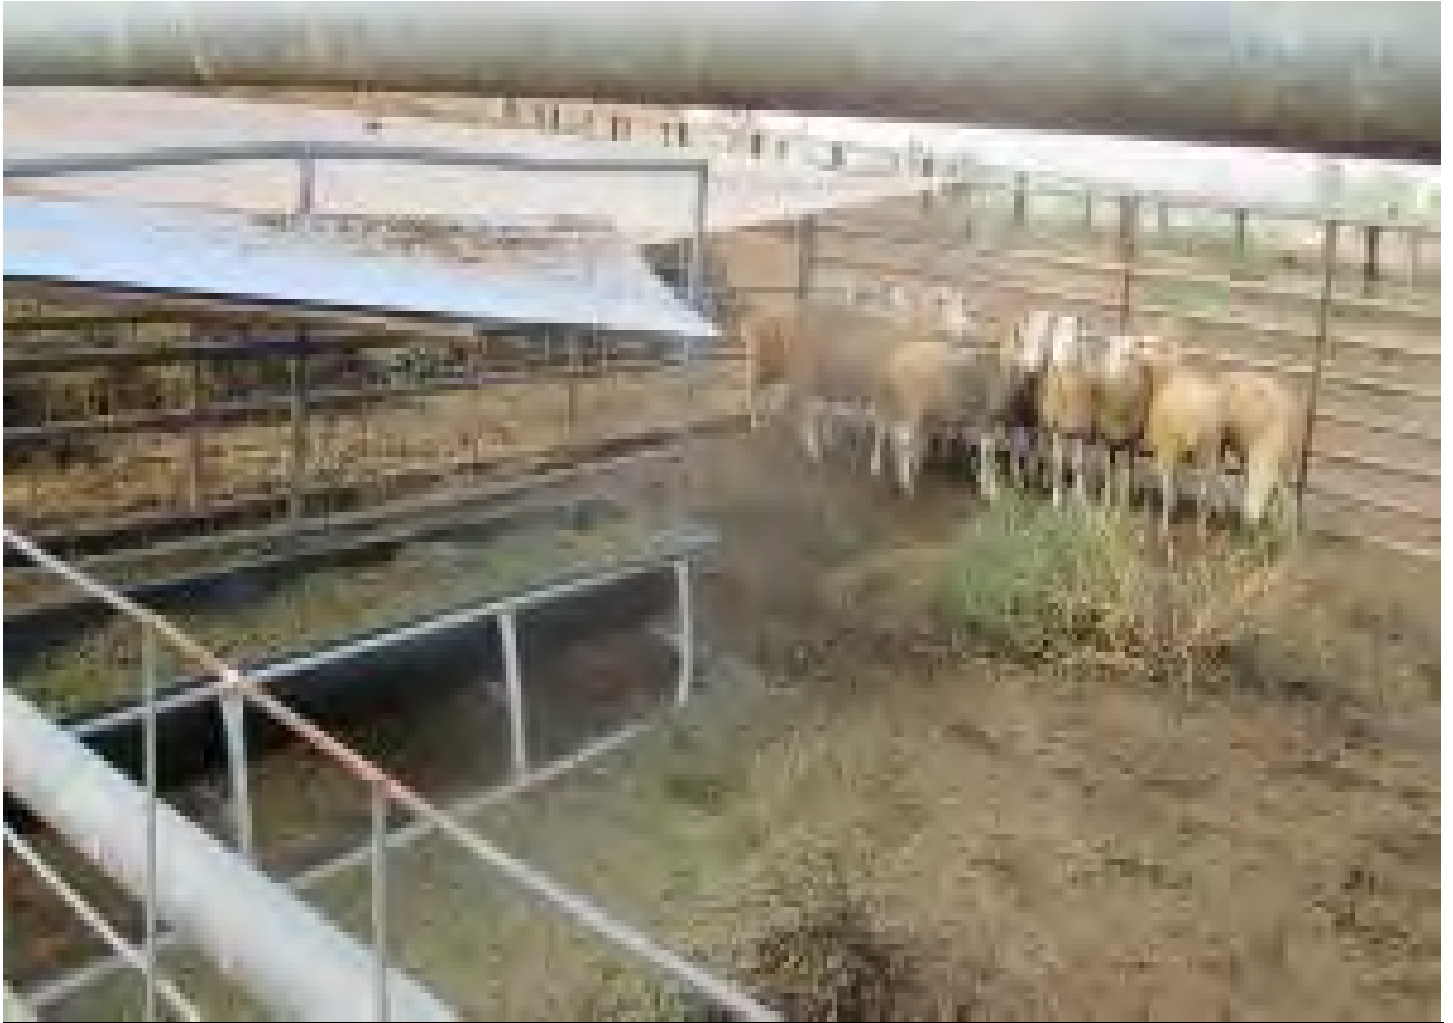
CFR : 3.127(b)

Sheep pen with only a shade cloth for cover, no shelter from rain.

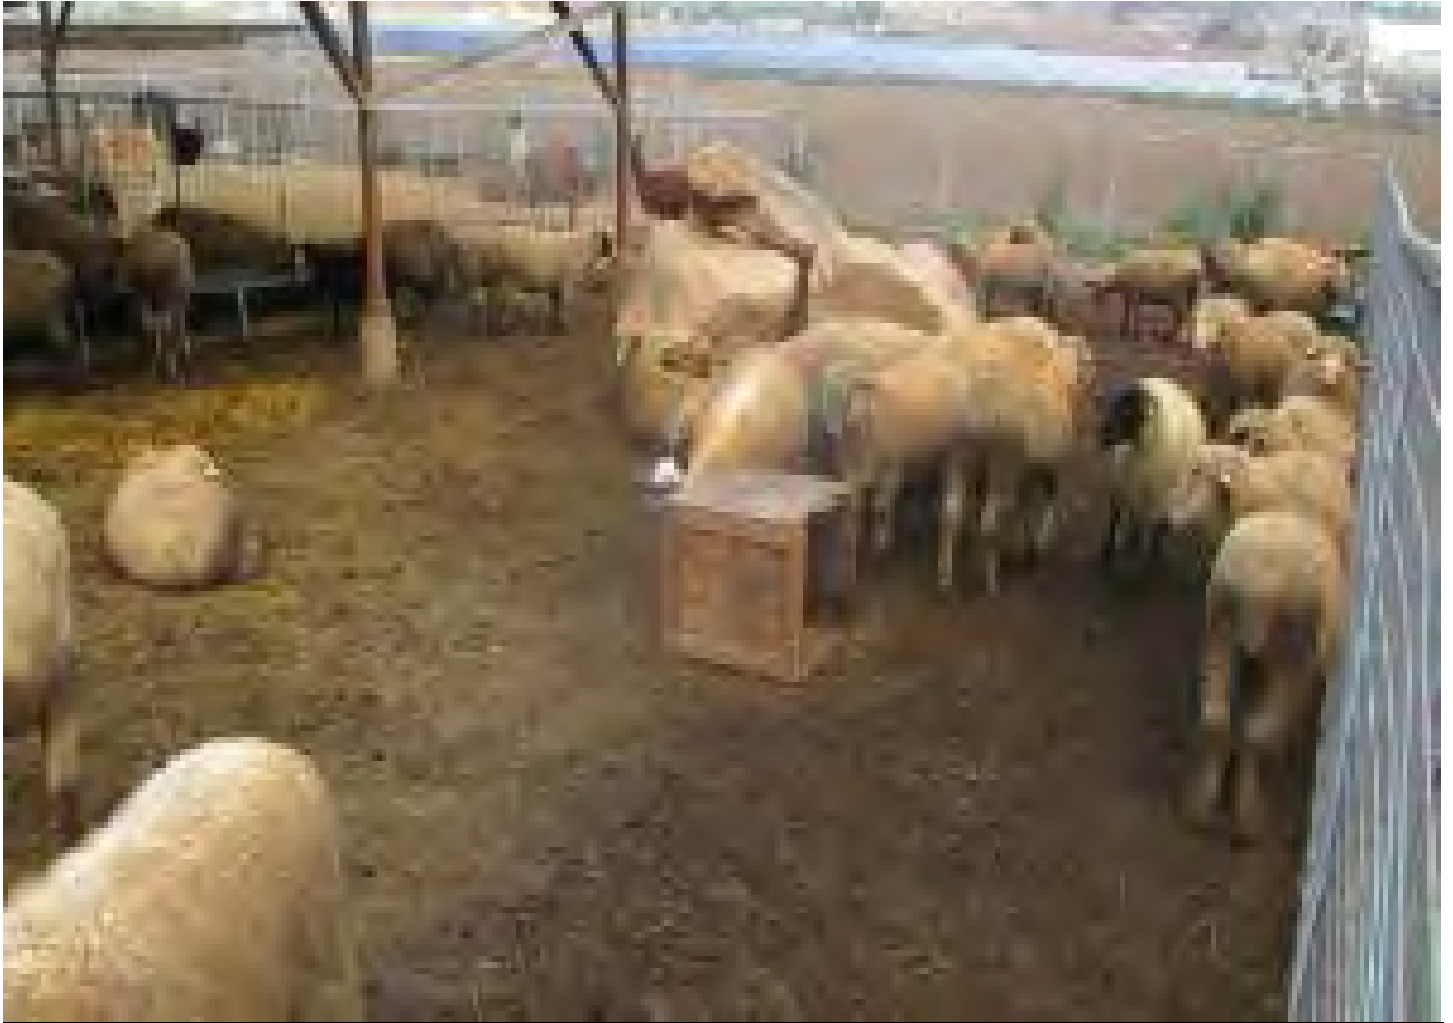
CFR : 3.127(b)

Large sheep pen with muddy ground and insufficient space under shelter for all animals to be protected from recent rain.

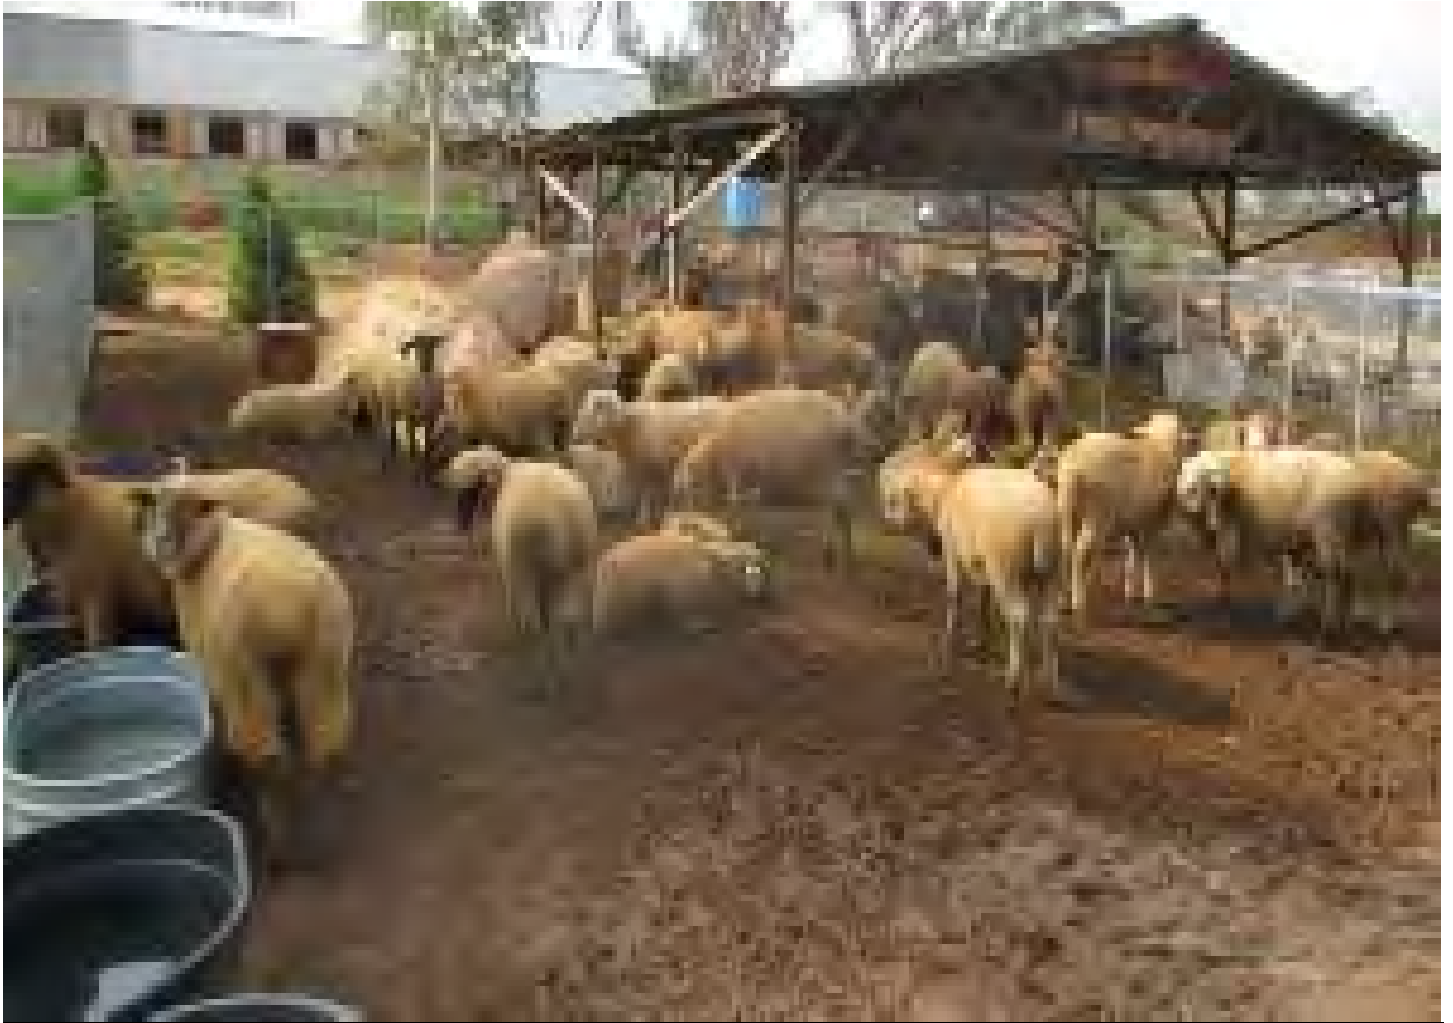
CFR : 3.127(b)

Large sheep pen with muddy ground and insufficient space under shelter for all animals to be protected from recent rain.

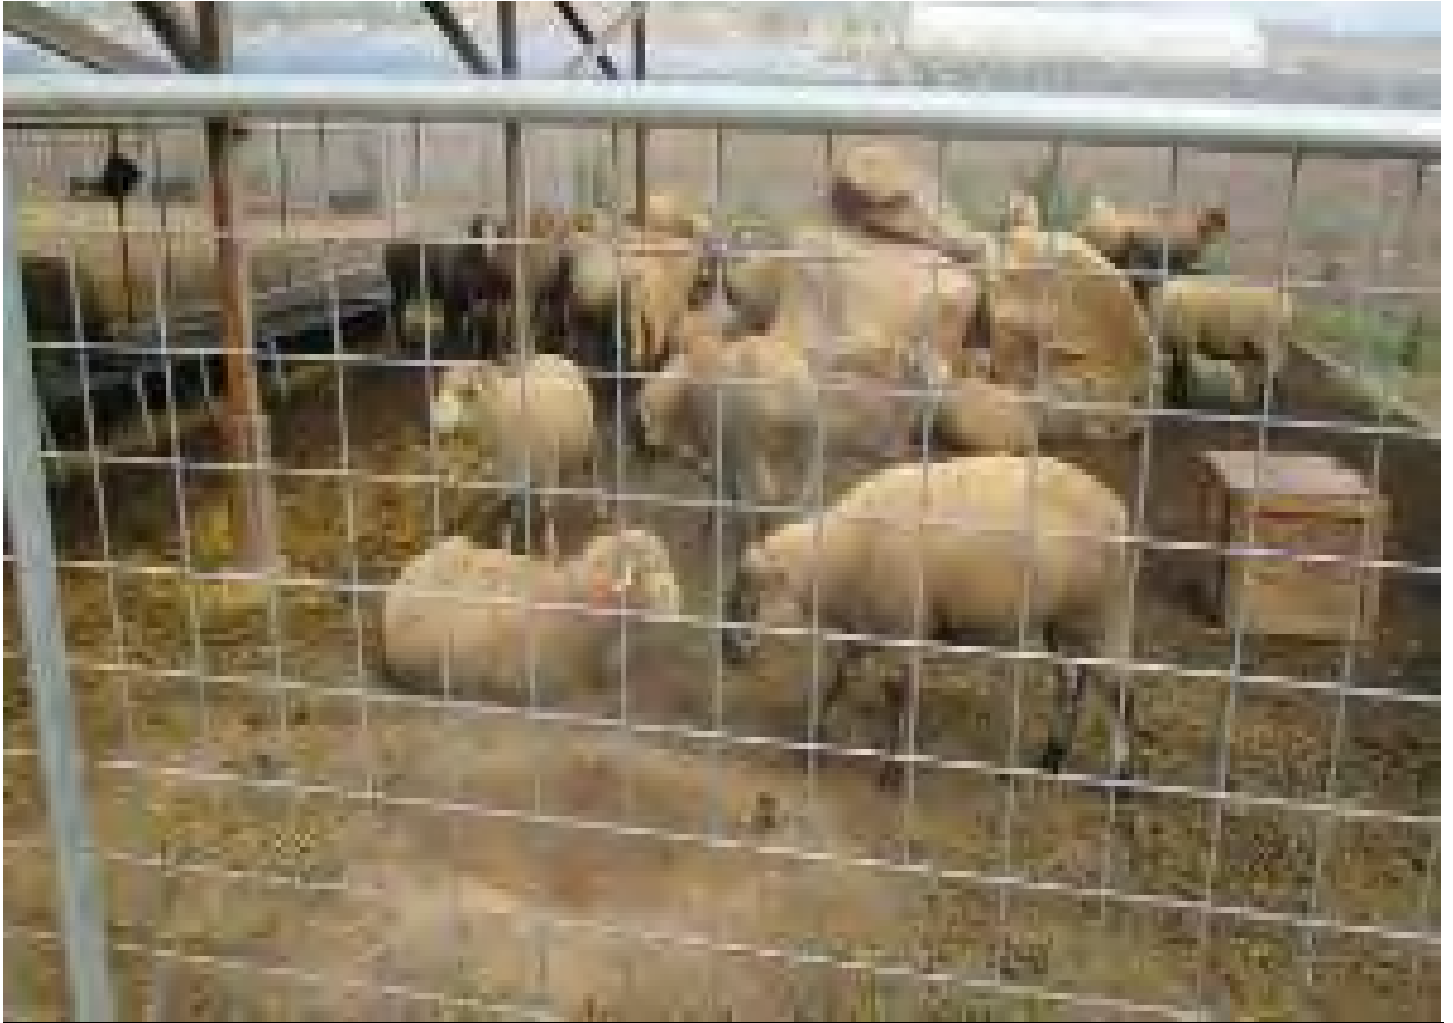
CFR : 3.127(b)

One dry spot in large sheep pen with muddy ground and insufficient space under shelter for all animals to be protected from recent rain.

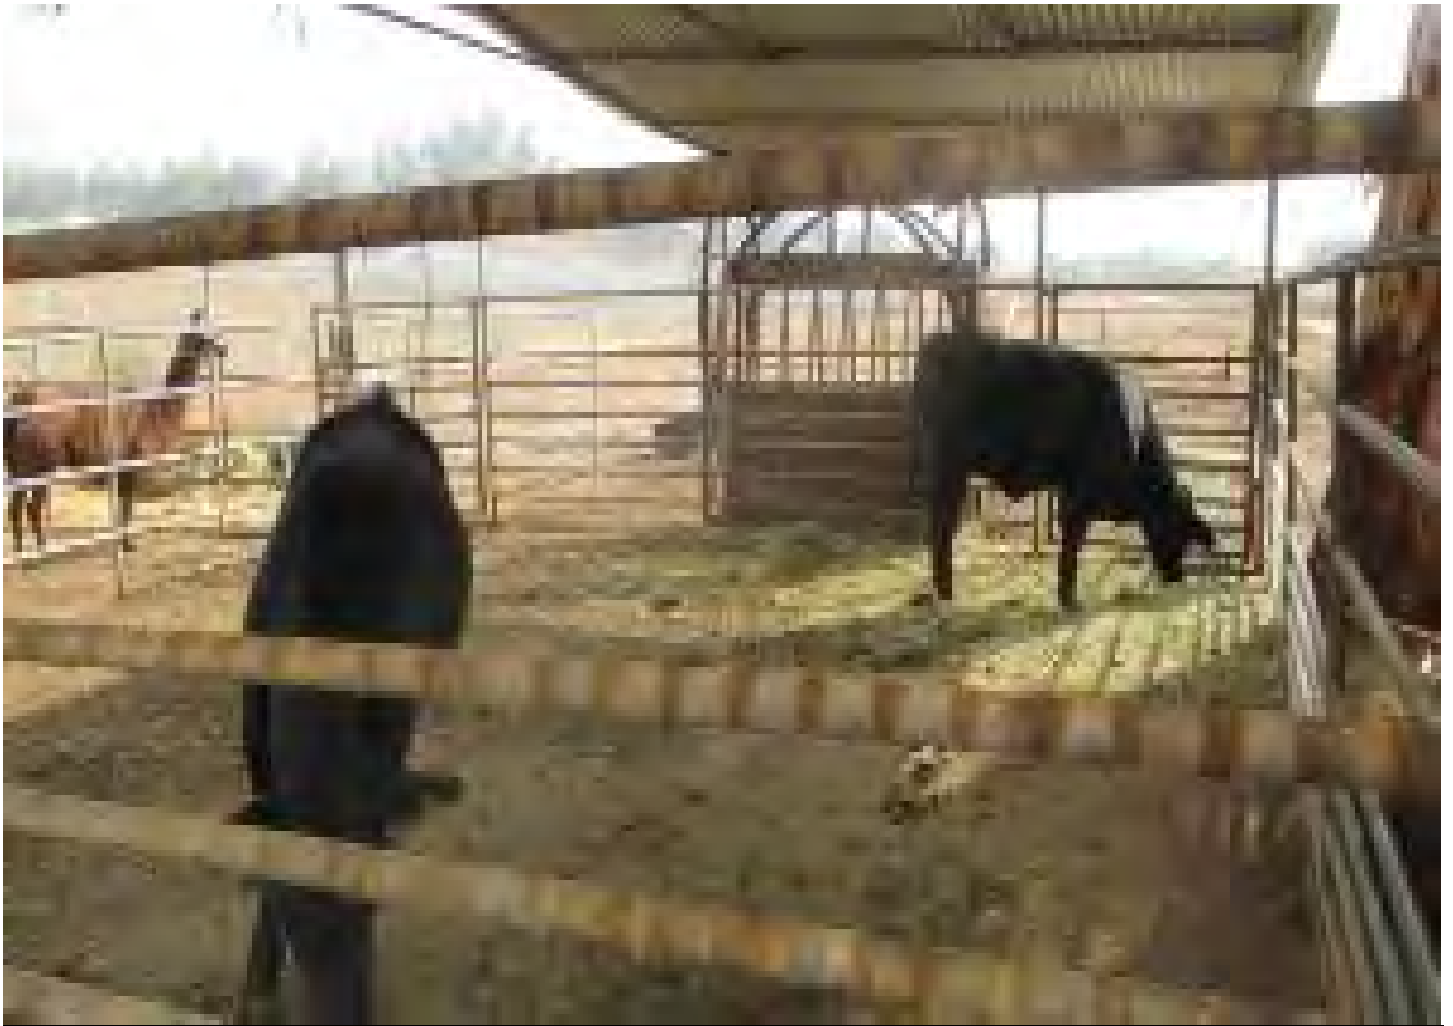
CFR : 3.129(b)

Cows with hay intermingled with fecal material on the ground.

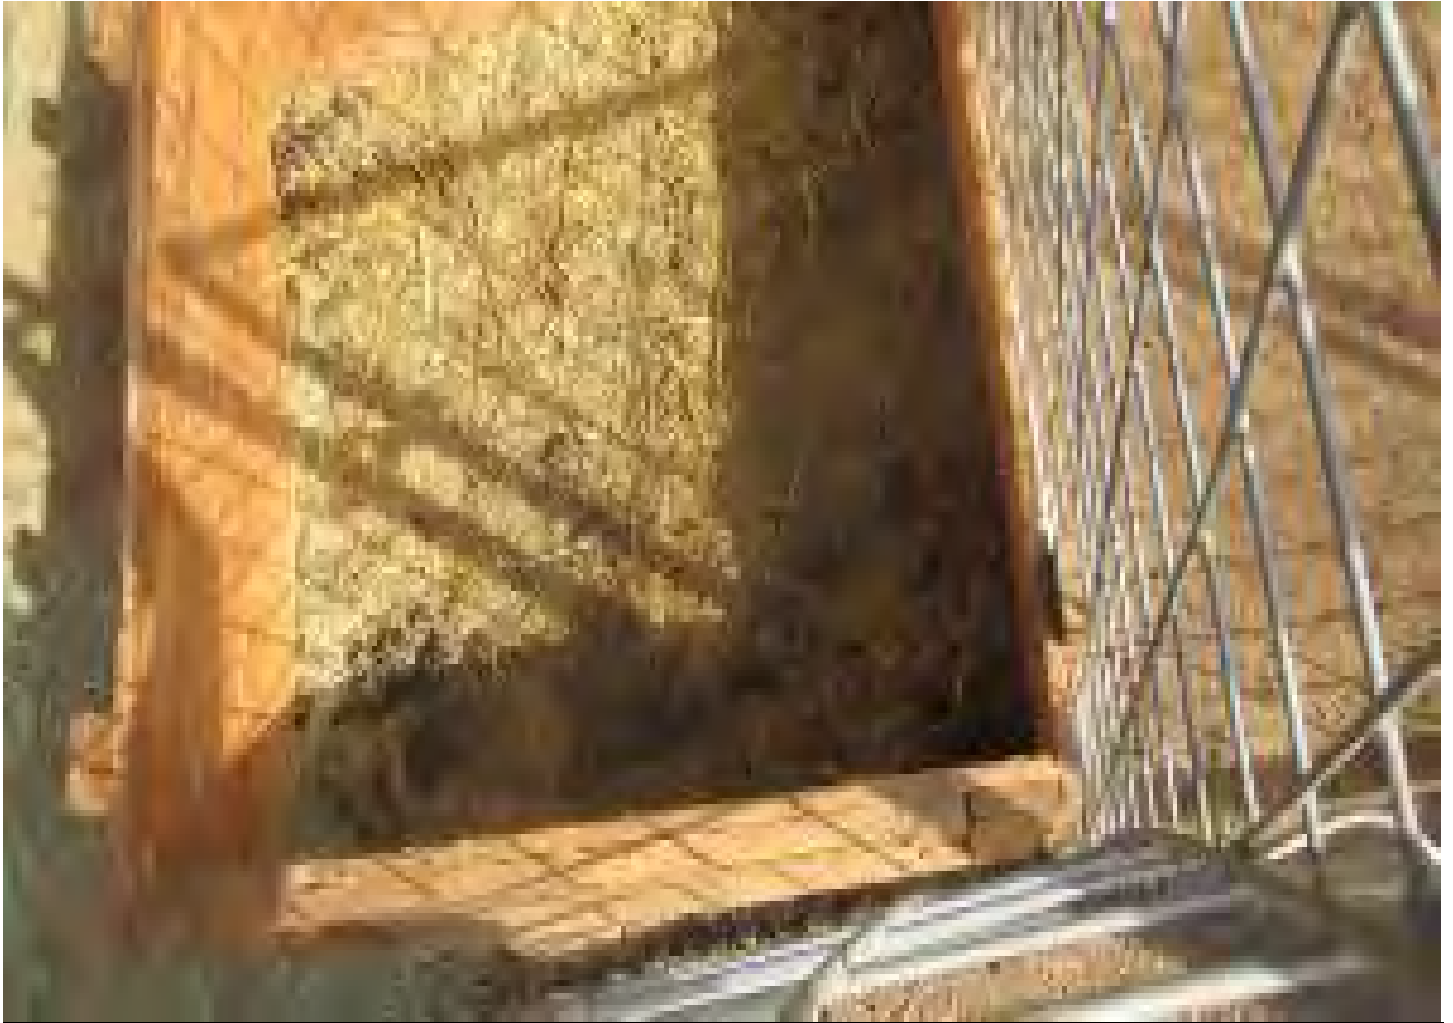
CFR : 3.129(b)

Food receptacle with fecal material in the goat/llama pen.

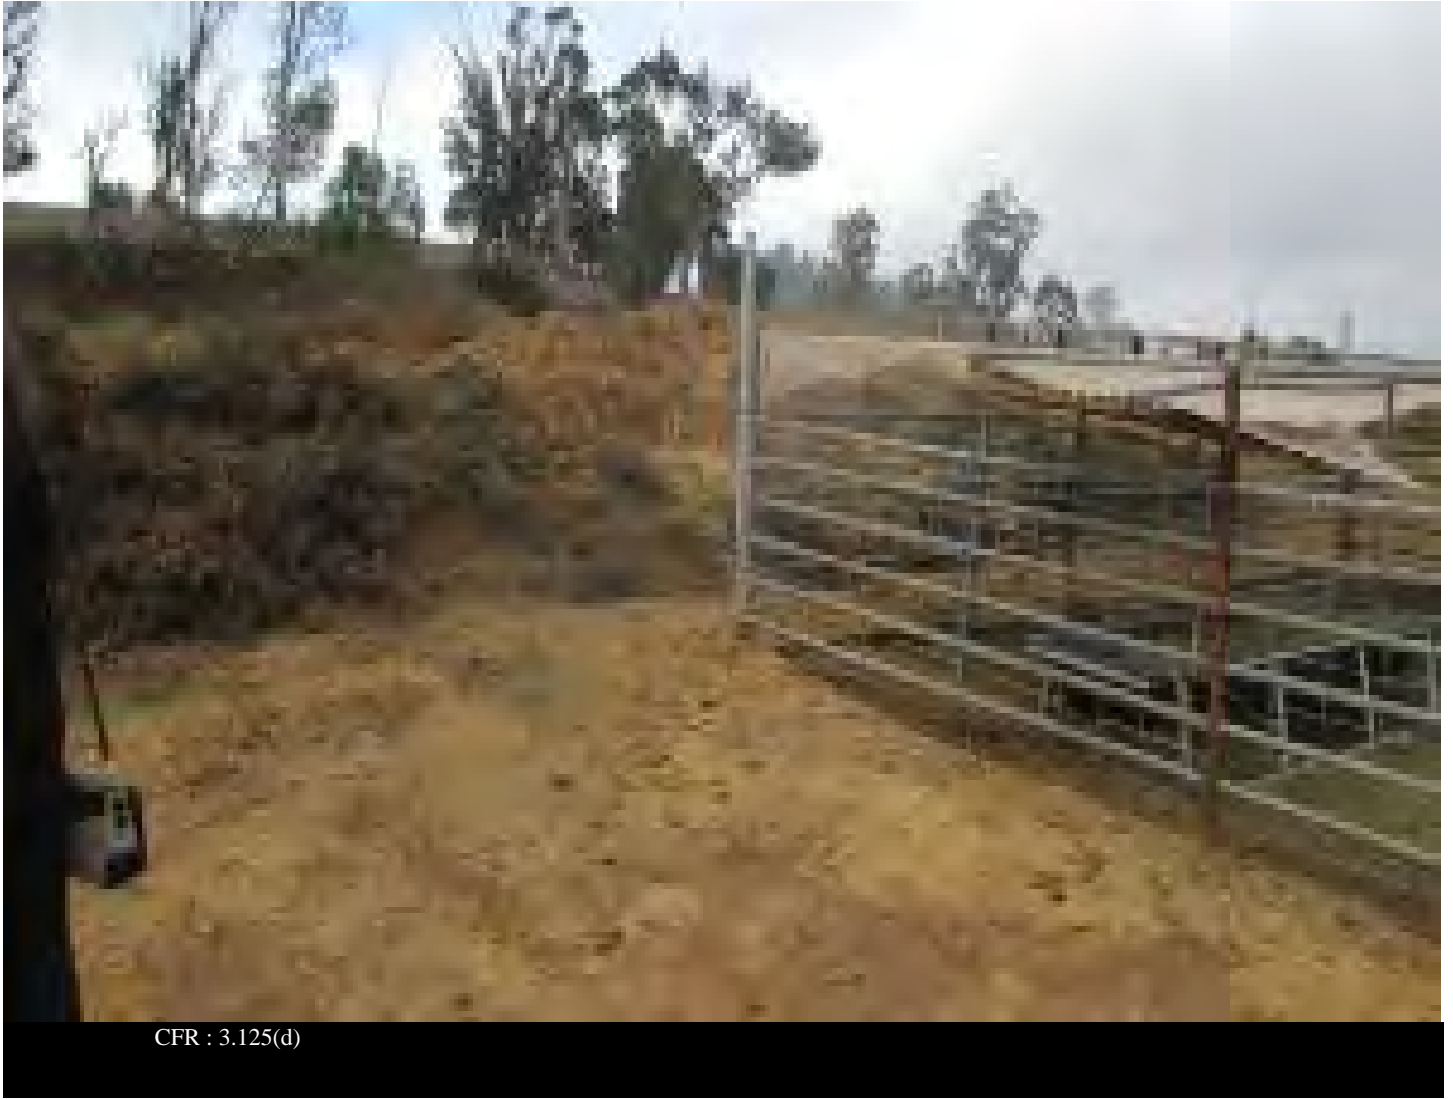
CFR : 3.125(d)

Sheep pen adjacent to uncovered sprawling waste pile.

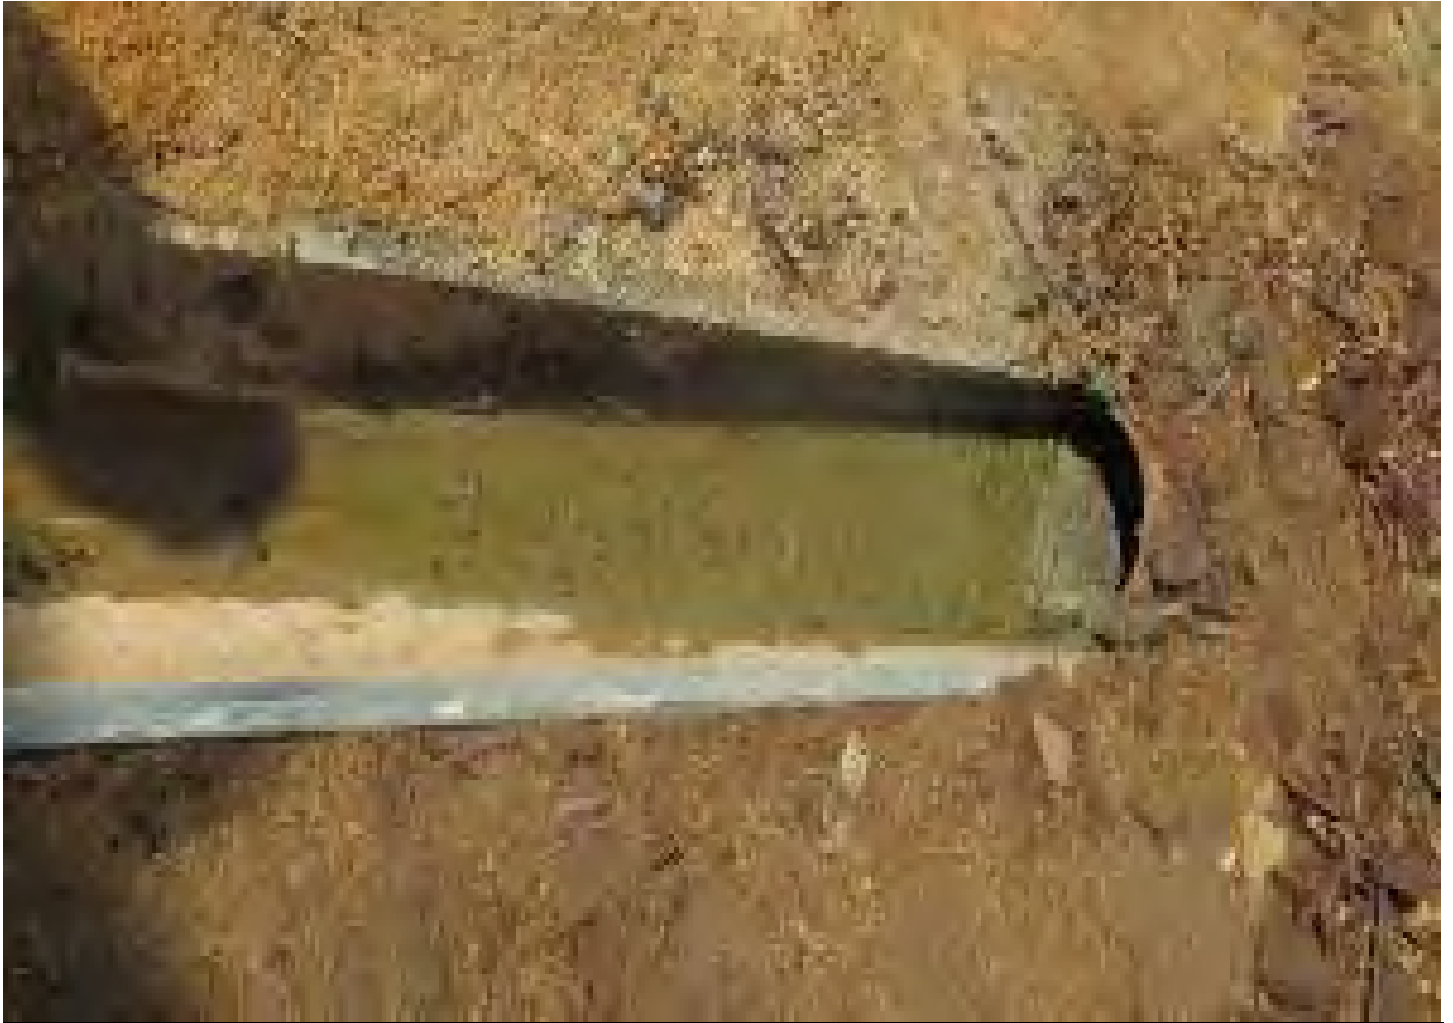
CFR : 3.50(d)

Open drainage pipe with fecal material built up exiting the rabbit barn.
